50-Year Recertification Thermography Report

Meadow Condominium Association, Inc
377 SW 56th Ave, Margate, FL 33068

MEADOWS CONDOMINIUM

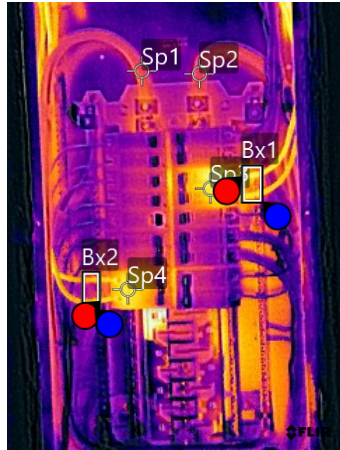
Club House - Panel A

Repairs Are Not Required

The temperature observed in the 2P-50A circuit breaker at positions 6 and 8 is the result of the consumption measured at the time of the inspection.
 Phase A: 16.5 Amp
 Phase B: 16.9 Amp
 Also, the temperature observed in the 2P-50A circuit breaker at positions 15 and 17 is the result of the consumption measured at the time of the inspection.
 Phase A: 15.4 Amp
 Phase B: 15.9 Amp

Deficiencies were not observed with this equipment at the time of the inspection.

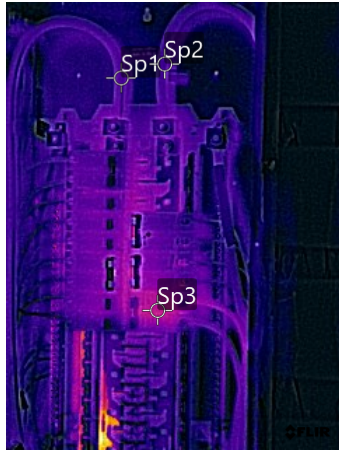
Club House - Panel B

Repairs Are Not Required

Deficiencies were not observed at this equipment at the time of the inspection.

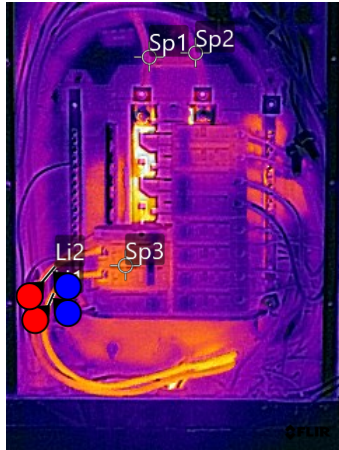
Club House - Panel C

Repairs Are Not Required

The temperature observed in the 2P-60A circuit breaker at positions 11 and 13 is the result of the consumption measured at the time of the inspection.
Phase A: 10.4 Amp
Phase B: 11.4 Amp

Deficiencies were not observed with this equipment at the time of the inspection.

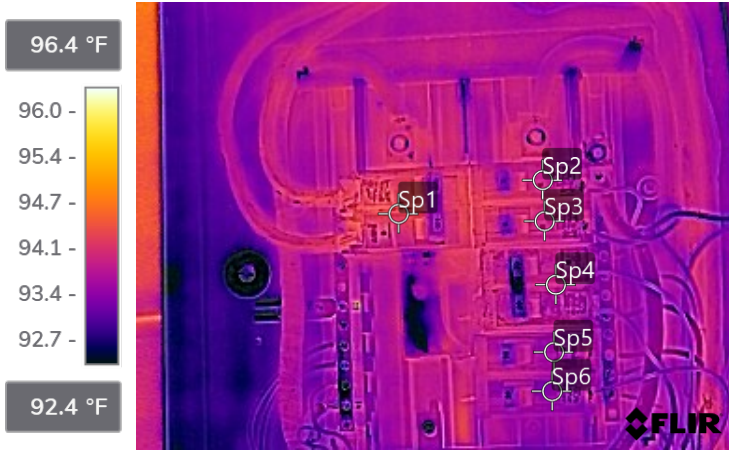
House Panel - Tennis Court - Electrical Panel A

Repairs Are Not Required

Deficiencies were not observed at this equipment at the time of the inspection.

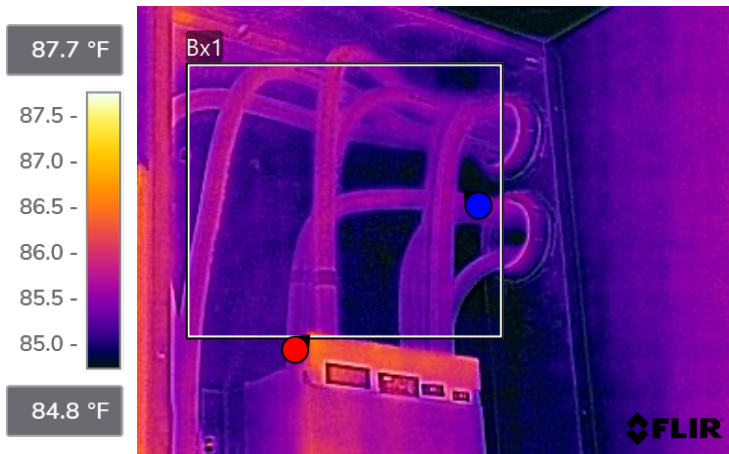
Building 100 - Main Electrical Room - Main Service Disconnect #1 - Feeders

Repairs Are Not Required

Deficiencies were not observed at this equipment at the time of the inspection.

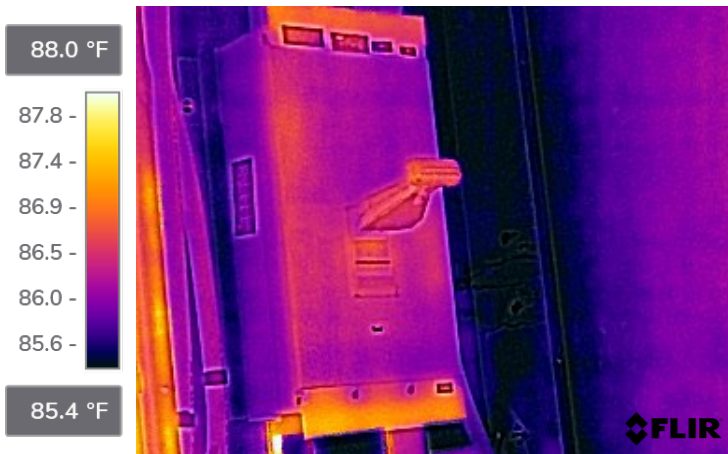
Building 100 - Main Electrical Room - Main Service Disconnect #1 - Circuit Breaker

Repairs Are Not Required

Deficiencies were not observed at this equipment at the time of the inspection.

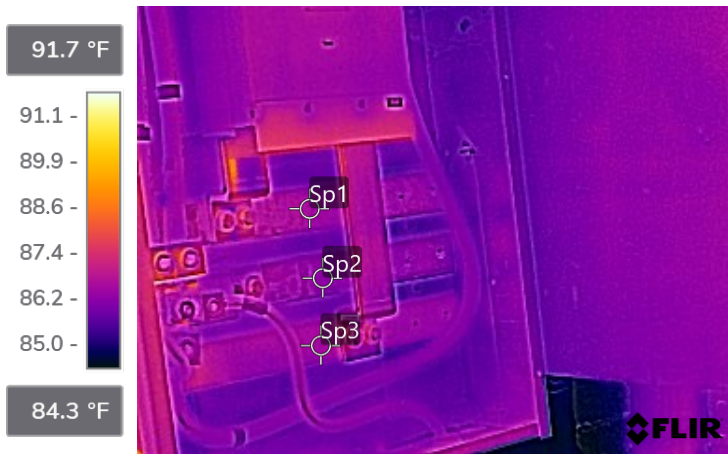
Building 100 - Main Electrical Room - Main Service Disconnect #1 - Distribution bars

Repairs Are Not Required

Deficiencies were not observed at this equipment at the time of the inspection.

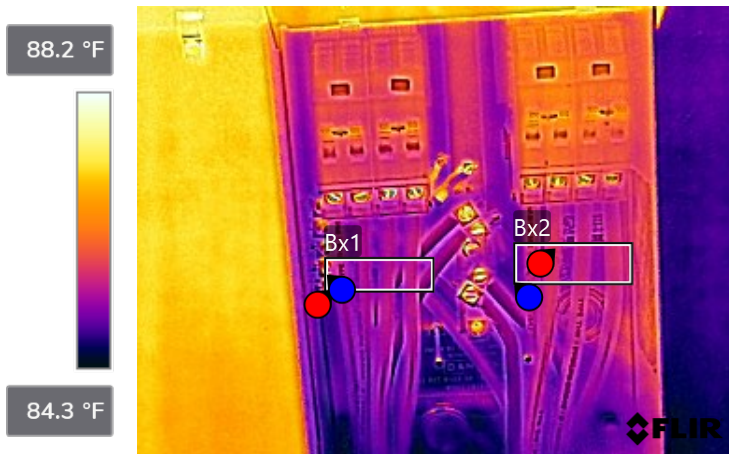
Building 100 - Main Electrical Room - Main #1 - Units' Feeders and Main Circuit Breakers

Repairs Are Not Required

Deficiencies were not observed at this equipment at the time of the inspection.

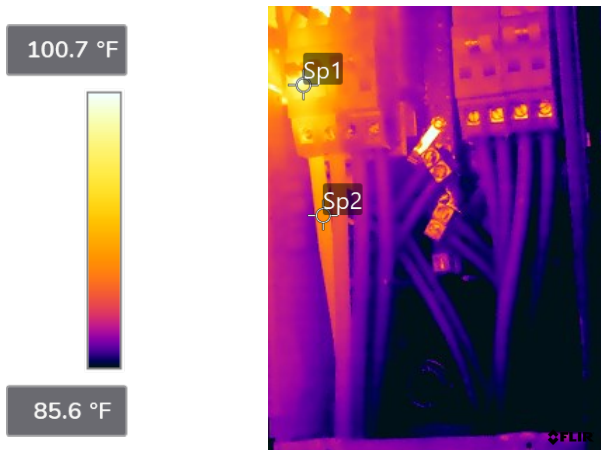
Building 100 - Main Electrical Room - Unit 111 - Main Breaker

- Building 100 – Main Electrical Room
Unit 11 – Main Breaker
See page #25
Minor Repair is Required.

Minor Repair Is Required

This condition could be a result of a malfunctioning of the circuit breaker. The contractor shall provide maintenance to this circuit breaker and its connections. If the issue continues, the circuit breaker shall be replaced by a new one of the same type and rating.

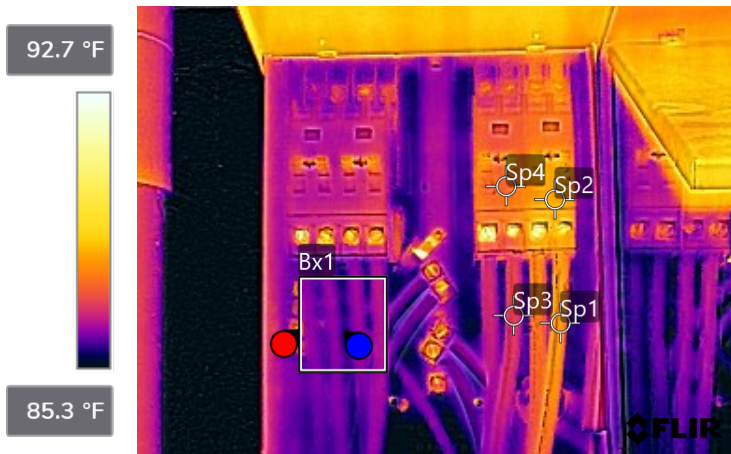
Building 100 - Main Electrical Room - Main #2 - Units' Feeders and Main Circuit Breakers

Repairs Are Not Required

The minor difference in temperature in Sp1 and Sp2 is a result of the temperature measured at the time of the inspection.
 Phase A: 9.7 Amp
 Phase B: 8.8 Amp
 Deficiencies were not observed with this equipment at the time of the inspection.
