50-Year Recertification Thermography Report

Meadow Condominium Association, Inc
377 SW 56th Ave, Margate, FL 33068

MEADOWS CONDOMINIUM

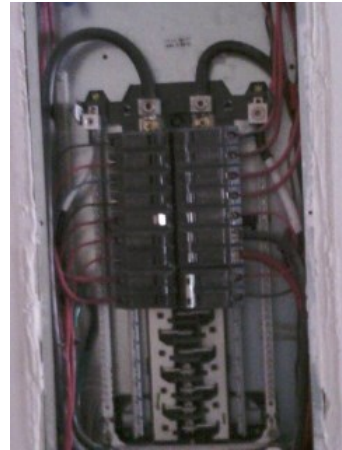
FLIR1548.jpg

The temperature observed in the 2P-50A circuit breaker at positions 6 and 8 is the result of the consumption measured at the time of the inspection.
 Phase A: 16.5 Amp
 Phase B: 16.9 Amp
 Also, the temperature observed in the 2P-50A circuit breaker at positions 15 and 17 is the result of the consumption measured at the time of the inspection.
 Phase A: 15.4 Amp
 Phase B: 15.9 Amp

Deficiencies were not observed with this equipment at the time of the inspection.

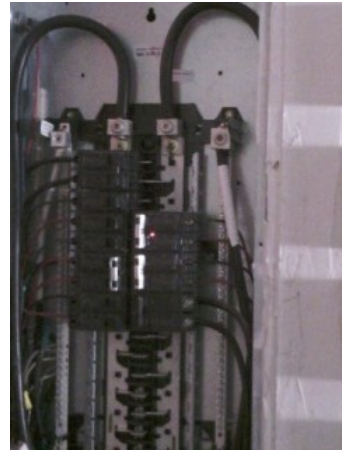
FLIR1554.jpg

Deficiencies were not observed at this equipment at the time of the inspection.

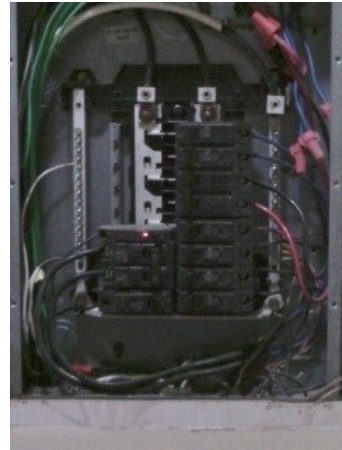
FLIR1558.jpg

The temperature observed in the 2P-60A circuit breaker at positions 11 and 13 is the result of the consumption measured at the time of the inspection.
Phase A: 10.4 Amp
Phase B: 11.4 Amp

Deficiencies were not observed with this equipment at the time of the inspection.

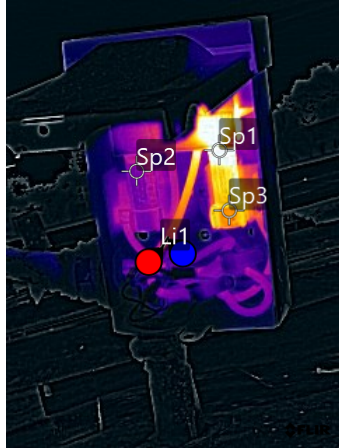
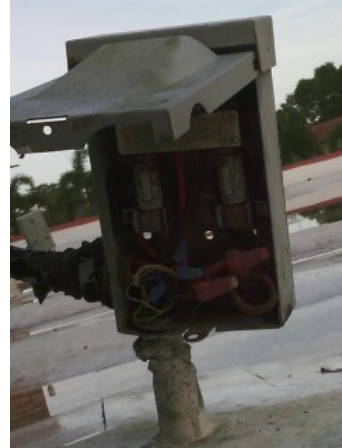
Club House - Roof - East AC Disconnect

- Club House – Roof
East AC Disconnect
See page #9
Critical Repair is Required.

Critical Repair is Required

Critical - Immediately Repair is Required
The electrical contractor shall replace the existing disconnect switch with a new one rated for the condition of use.

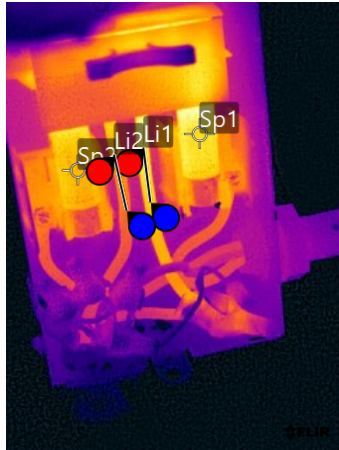
Club House - Roof - West AC Disconnect

- Club House – Roof
West AC Disconnect
See page #10
Minor Repair is Required.

Minor repair is Required

Preventive maintenance will be required on this disconnect. However, this disconnect switch will be replaced as per the comment included in the electrical supplemental report.

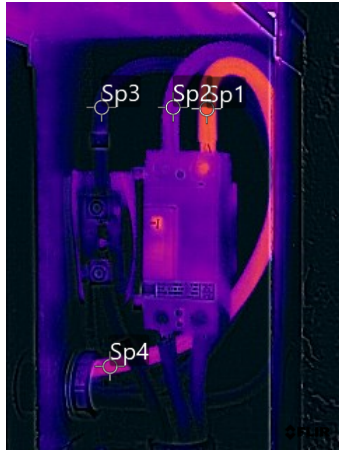
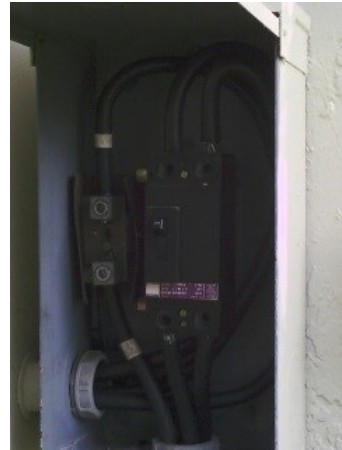
Club House - 200A Main Service Disconnect #1

- Club House
200A Main Service Disconnect #1
See page #11
Minor Repair is Required.

Minor repair is Required

Minor Repair is Required

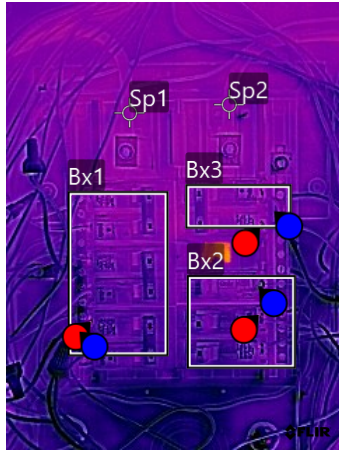
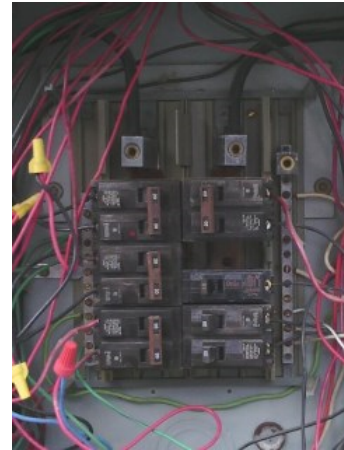
House Panel - Tennis Court - Electrical Panel B

Repairs Are Not Required

Deficiencies were not observed at this equipment at the time of the inspection.

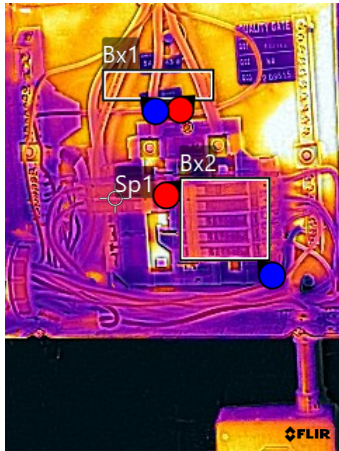
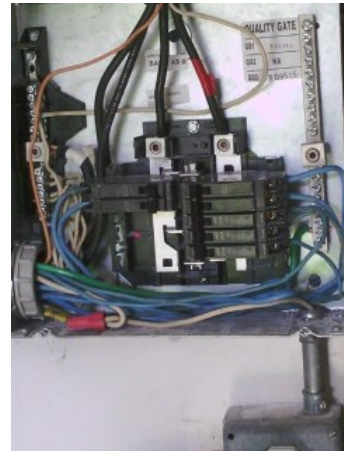
FLIR1618.jpg

Deficiencies were not observed at this equipment at the time of the inspection.

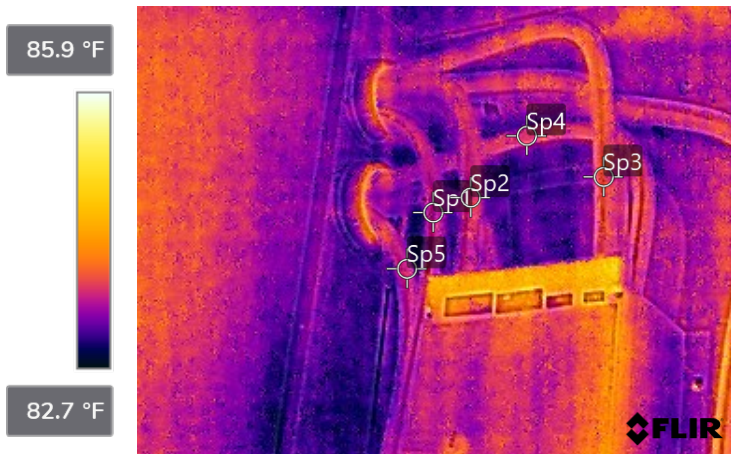
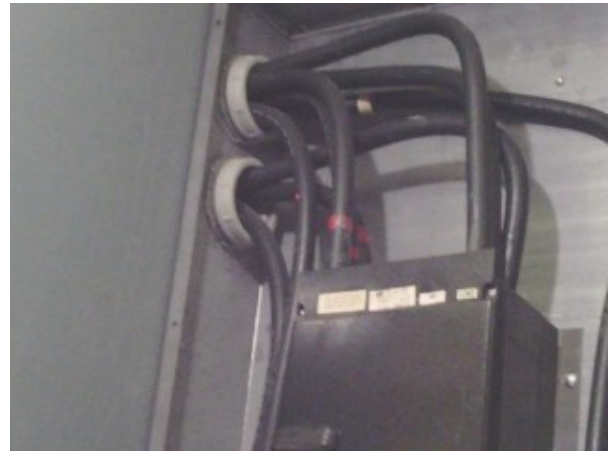
Building 200 - Main Electrical Room - Main Service Disconnect #1 - Feeders and Circuit Breakers

Deficiencies were not observed at this equipment at the time of the inspection.

Repairs Are Not Required

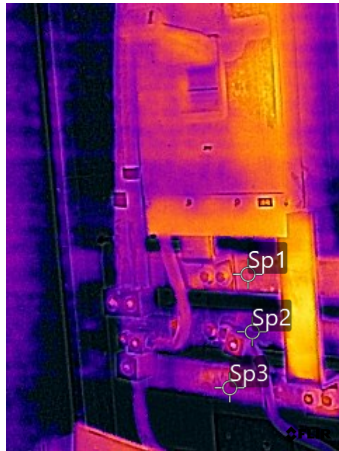
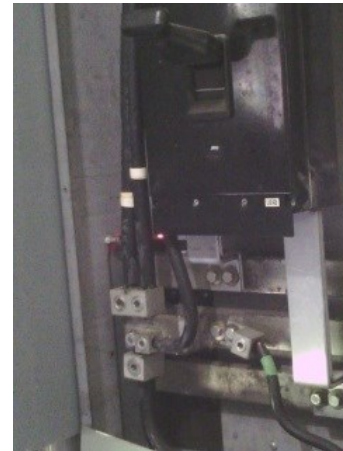
FLIR1632.jpg

Deficiencies were not observed at this equipment at the time of the inspection.

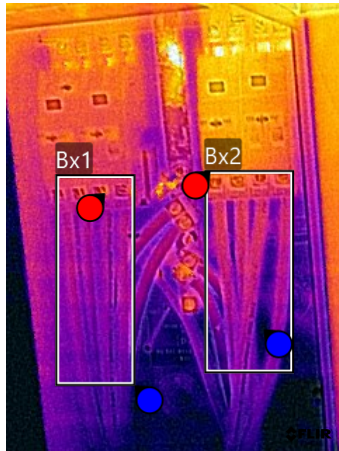
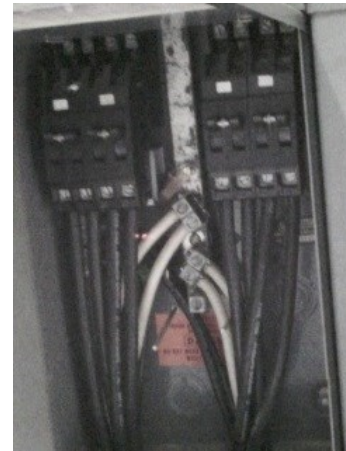
FLIR1634.jpg

Deficiencies were not observed at this equipment at the time of the inspection.

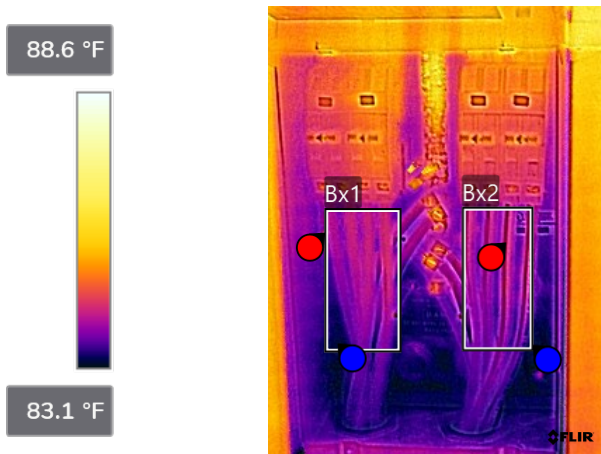
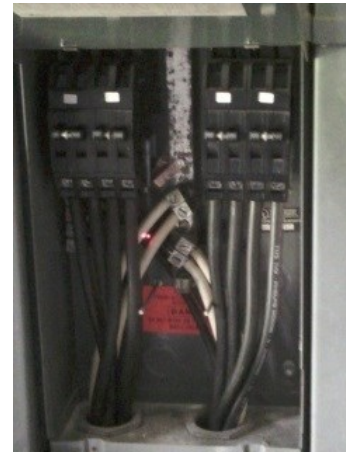
Building 200 - Main Electrical Room - Main #1 - Units' Feeders and Main Circuit Breakers

Deficiencies were not observed at this equipment at the time of the inspection.

Repairs Are Not Required

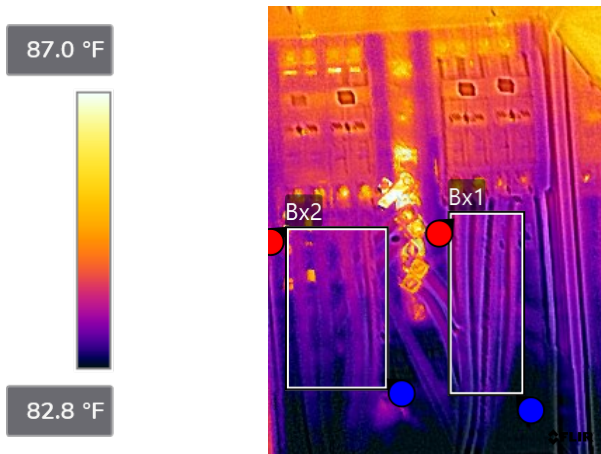
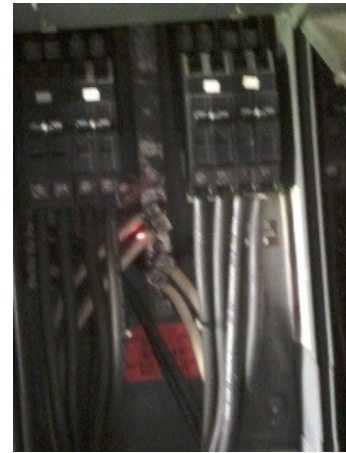
Building 200 - Main Electrical Room - Main #1 - Units' Feeders and Main Circuit Breakers

Deficiencies were not observed at this equipment at the time of the inspection.

Repairs Are Not Required

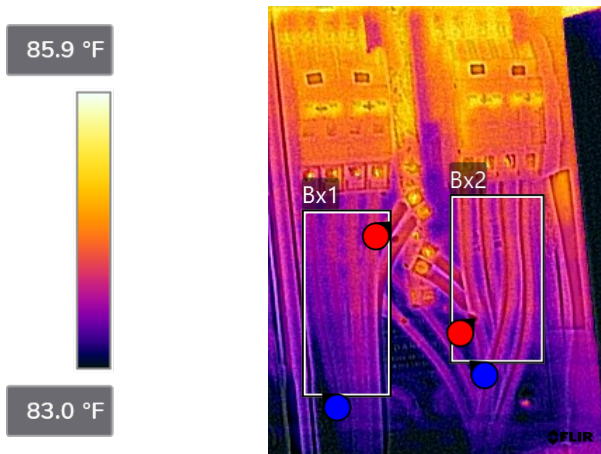
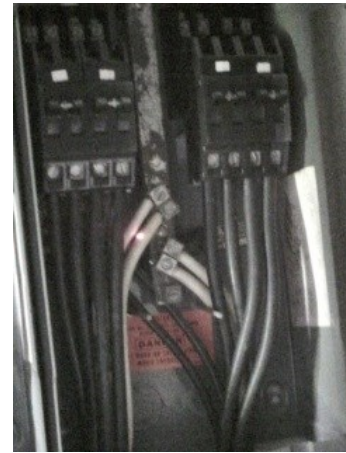
Building 200 - Main Electrical Room - Main #1 - Units' Feeders and Main Circuit Breakers

Deficiencies were not observed at this equipment at the time of the inspection.

Repairs Are Not Required

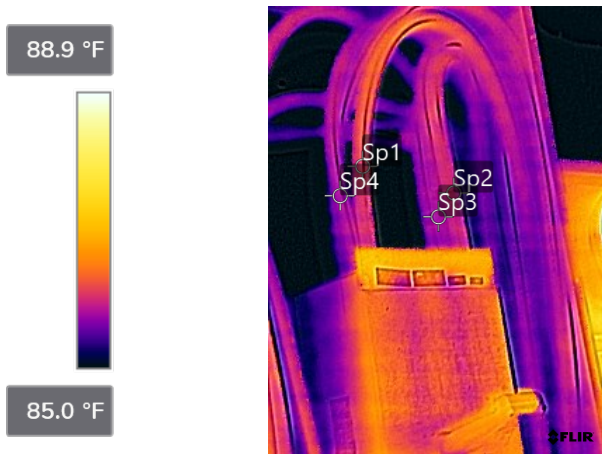
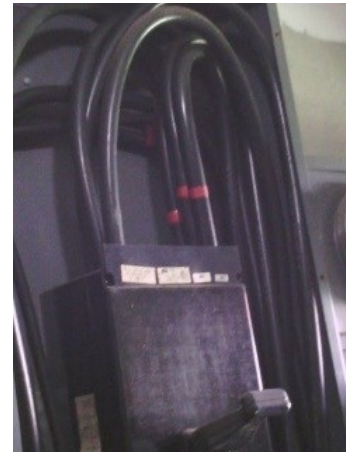
Building 200 - Main Electrical Room - Main Service Disconnect #2 - Feeders and Main Circuit Breaker

Deficiencies were not observed at this equipment at the time of the inspection.

Repairs Are Not Required

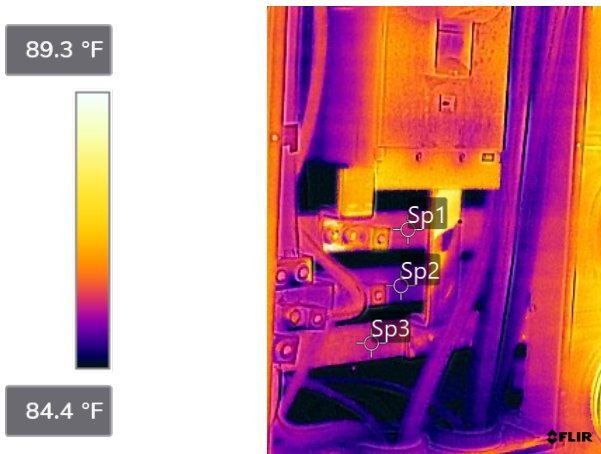
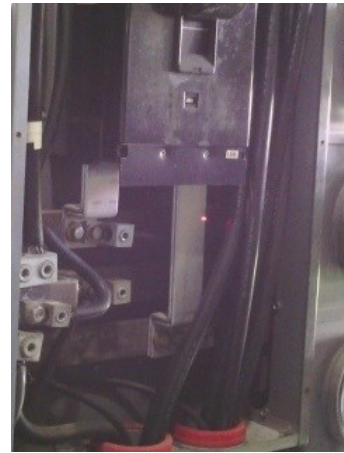
Building 200 - Main Electrical Room - Main Service Disconnect #2 - Main Circuit Breaker and Distribution Bar

Deficiencies were not observed at this equipment at the time of the inspection.

Repairs Are Not Required

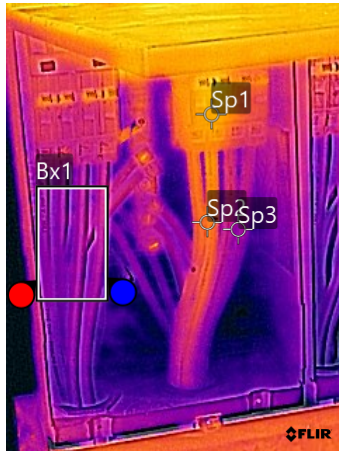
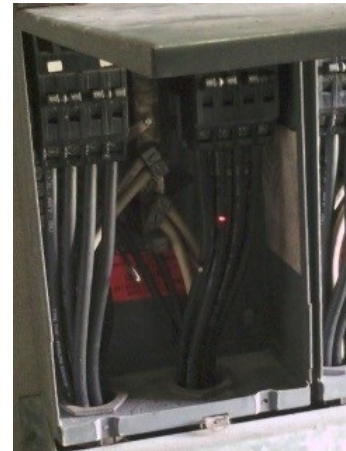
FLIR1654.jpg

The minor difference in color and temperature observed in Sp1 and Sp2 is a result of the temperature measured at the time of the inspection.

Deficiencies were not observed with this equipment at the time of the inspection.

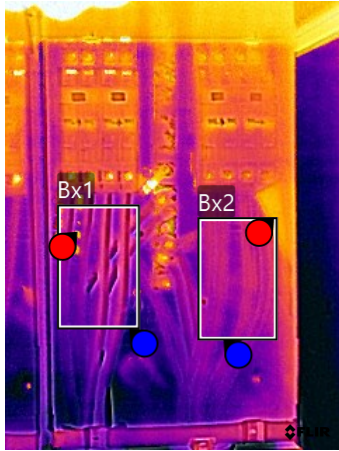
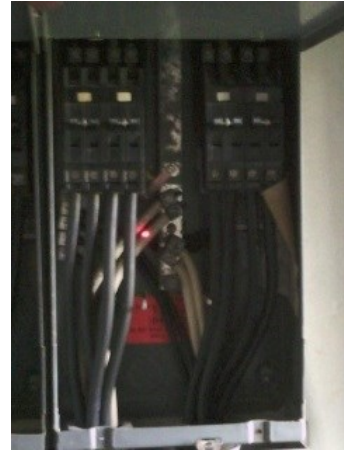
FLIR1656.jpg

Deficiencies were not observed at this equipment at the time of the inspection.

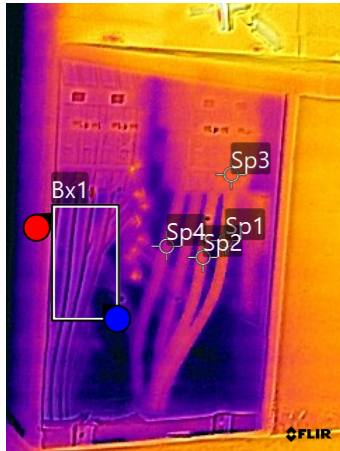
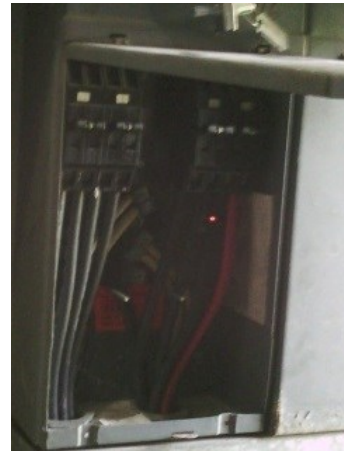
FLIR1658.jpg

The minor difference in color and temperature observed in Sp1 and Sp2 is a result of the temperature measured at the time of the inspection.

Deficiencies were not observed with this equipment at the time of the inspection.

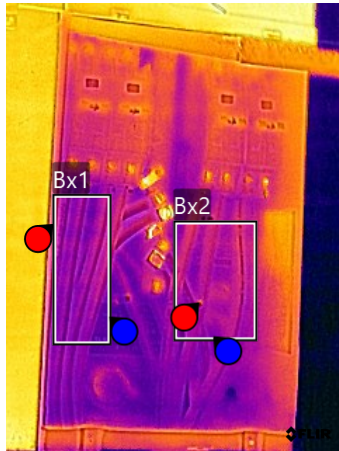
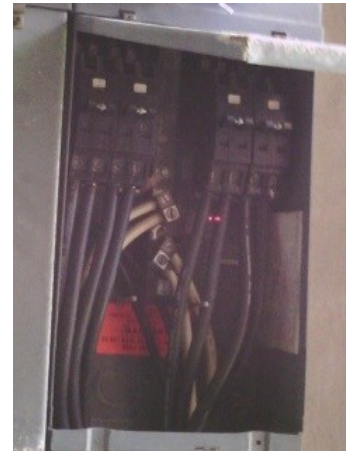
FLIR1660.jpg

Deficiencies were not observed at this equipment at the time of the inspection.

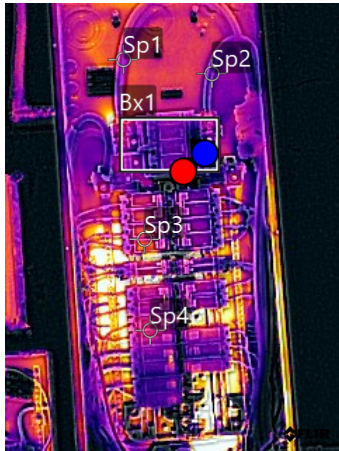
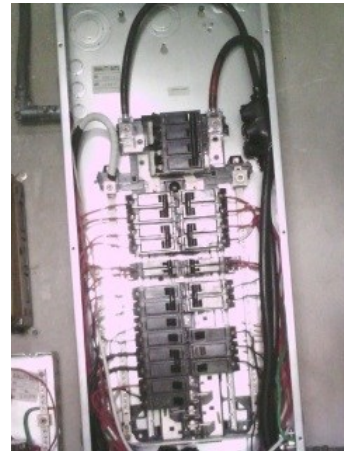
FLIR1644.jpg

Deficiencies were not observed at this equipment at the time of the inspection.

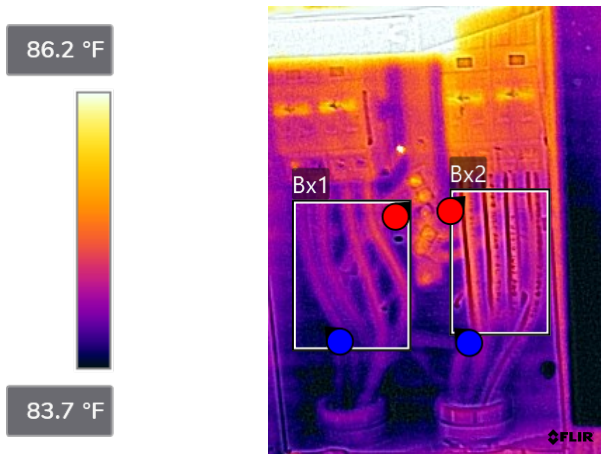
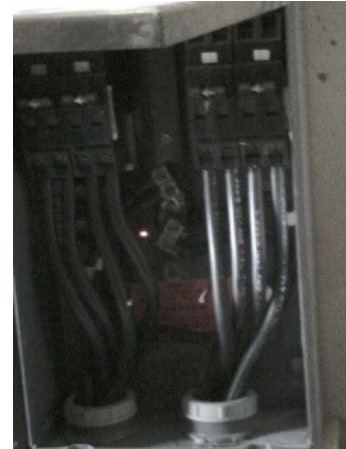
FLIR1682.jpg

Building 300 - Main Electrical Room - Main #1 - Units' Feeders and Main Circuit Breakers

Repairs Are Not Required

Deficiencies were not observed at this equipment at the time of the inspection.

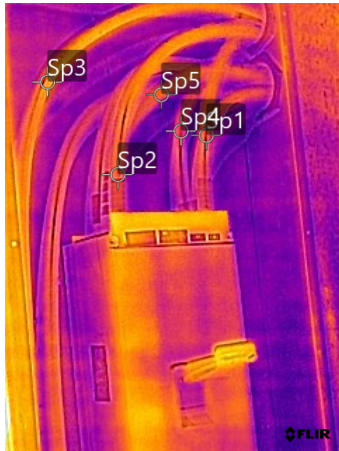
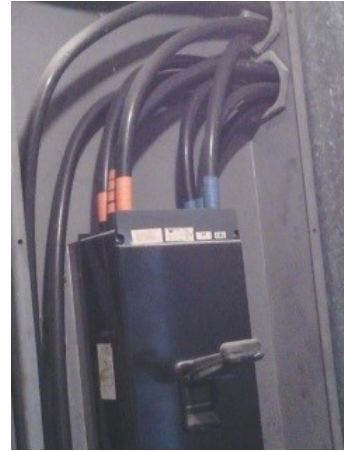
FLIR1694.jpg

Repairs Are Not Required

Deficiencies were not observed at this equipment at the time of the inspection.

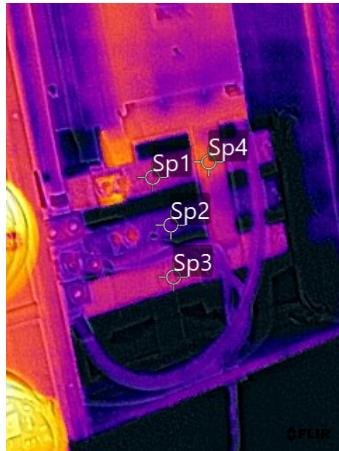
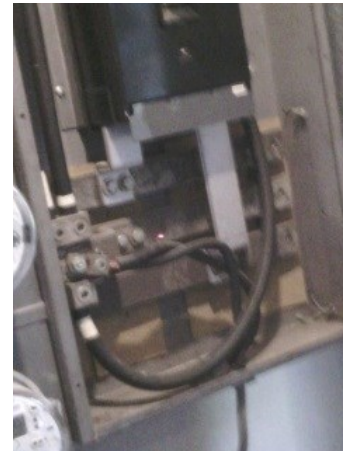
FLIR1696.jpg

Repairs Are Not Required

Deficiencies were not observed at this equipment at the time of the inspection.

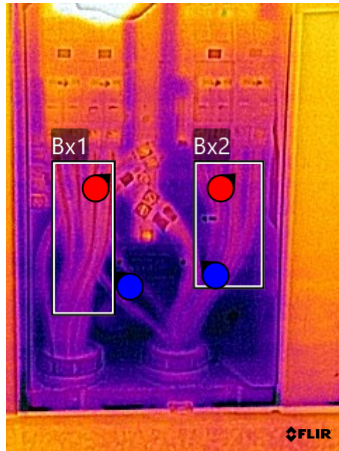
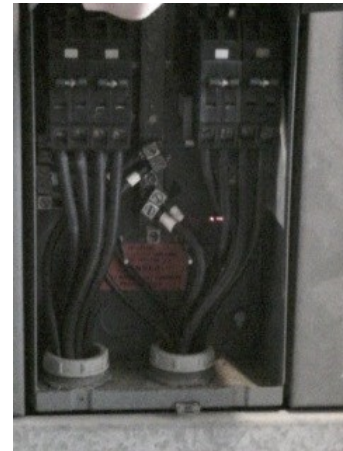
FLIR1700.jpg

Repairs Are Not Required

Deficiencies were not observed at this equipment at the time of the inspection.

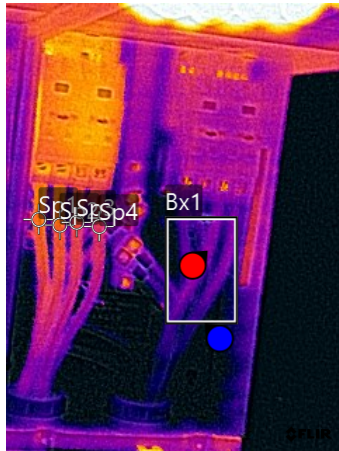
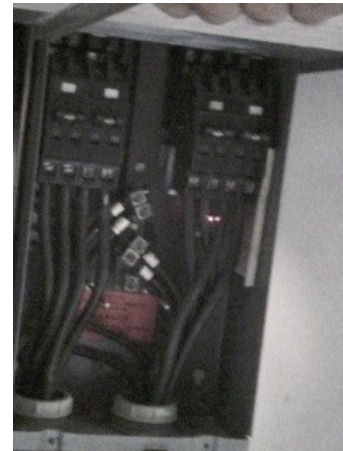
FLIR1702.jpg

Building 300 - Main Electrical Room - Main #2 - Units' Feeders and Main Circuit Breakers

Repairs Are Not Required

The minor difference in color and temperature observed in Sp1, Sp2, Sp3, and Sp4 is a result of the temperature measured at the time of the inspection.
The temperature in phases was observed between 2A and 5A.
Deficiencies were not observed with this equipment at the time of the inspection.

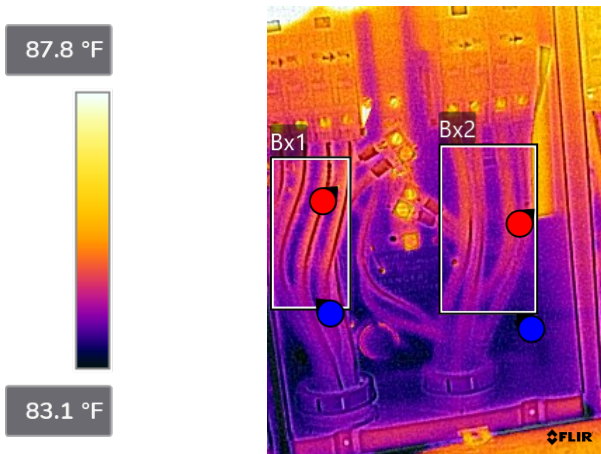
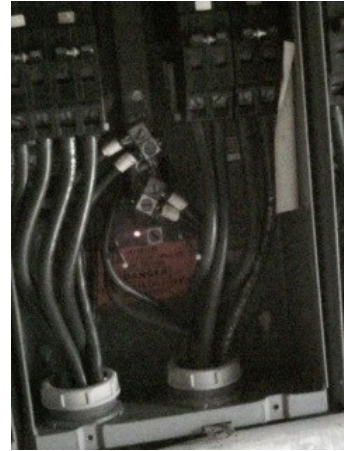
FLIR1706.jpg

Building 300 - Main Electrical Room - Main #2 - Units' Feeders and Main Circuit Breakers

Repairs Are Not Required

Deficiencies were not observed at this equipment at the time of the inspection.

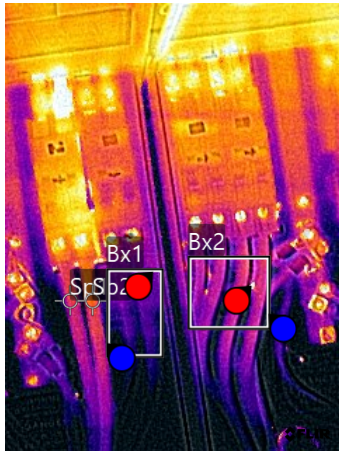
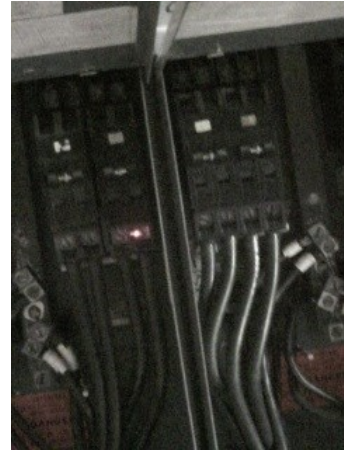
FLIR1708.jpg

Repairs Are Not Required

The minor difference in color and temperature observed in Sp1 and Sp2 is a result of the temperature measured at the time of the inspection.

Deficiencies were not observed with this equipment at the time of the inspection.

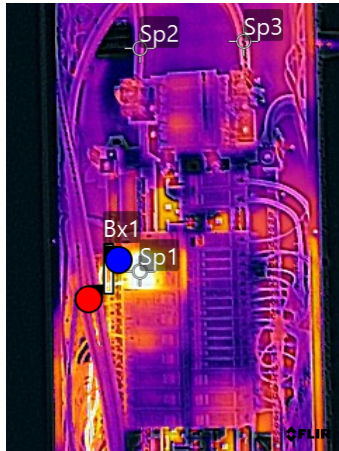
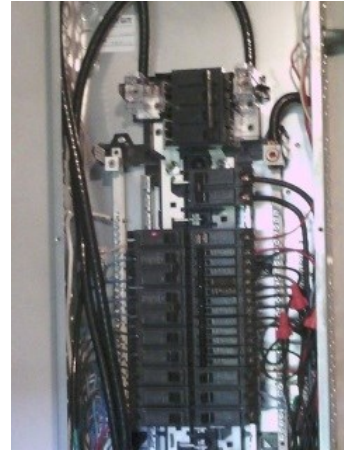
FLIR1688.jpg

Minor Repair is Required

Minor Repair Needed.
 The observed temperature in the breaker and wire is a result of the high consumption measured in this circuit at the time of the inspection (18.4A). This consumption is 90% of the breaker's rating; therefore, some of the loads connected at this circuit breaker shall be transferred to another 240V circuit, or the circuit breaker and wires shall be increased.

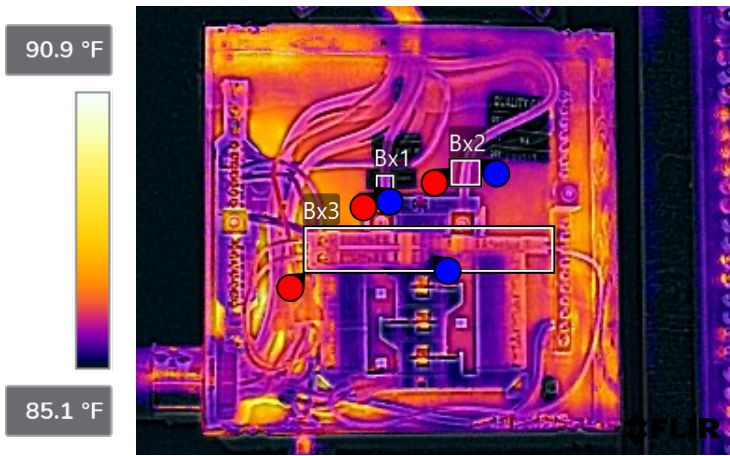
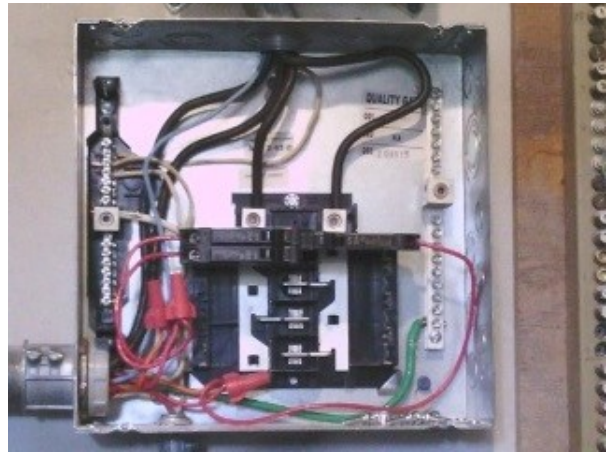
FLIR1690.jpg

Repairs Are Not Required

Deficiencies were not observed at this equipment at the time of the inspection.

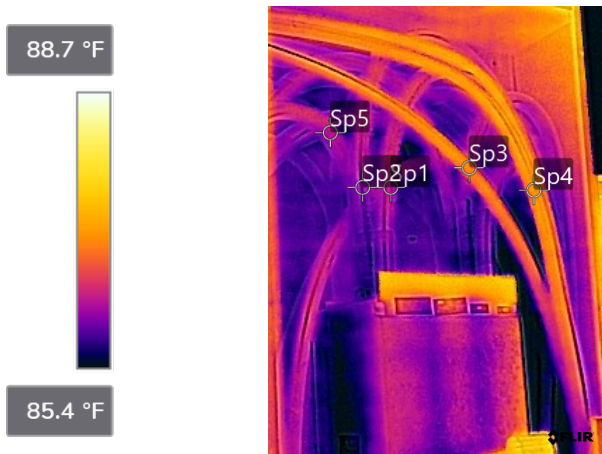
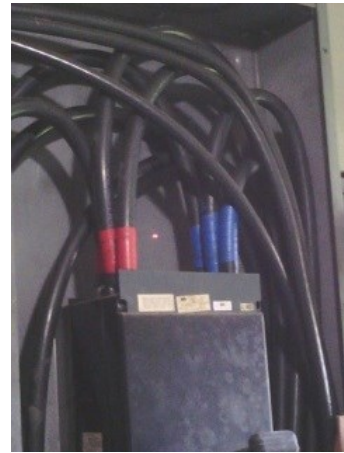
FLIR1710.jpg

Building 400 - Main Electrical Room - Main Service Disconnect #1 - Feeders and Circuit Breakers

Repairs Are Not Required

Deficiencies were not observed at this equipment at the time of the inspection.

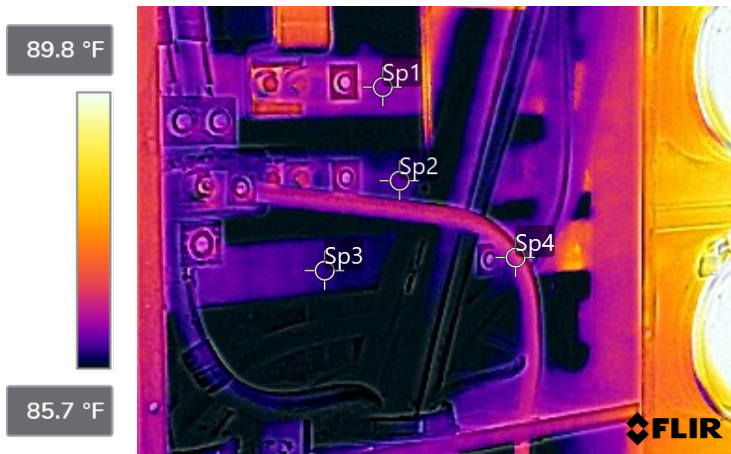
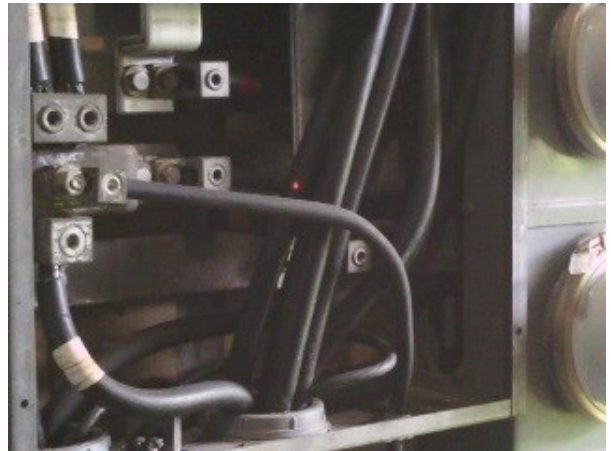
FLIR1712.jpg

Building 400 - Main Electrical Room - Main Service Disconnect #1 - Circuit Breakers and Distribution Bars

Repairs Are Not Required

Deficiencies were not observed at this equipment at the time of the inspection.

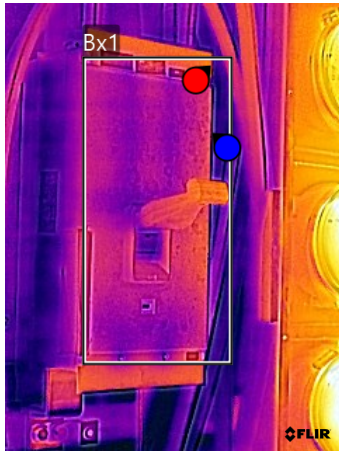
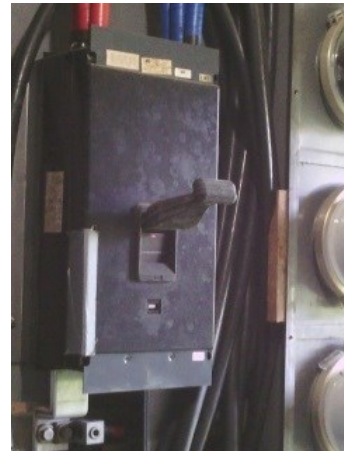
FLIR1714.jpg

Repairs Are Not Required

Deficiencies were not observed at this equipment at the time of the inspection.

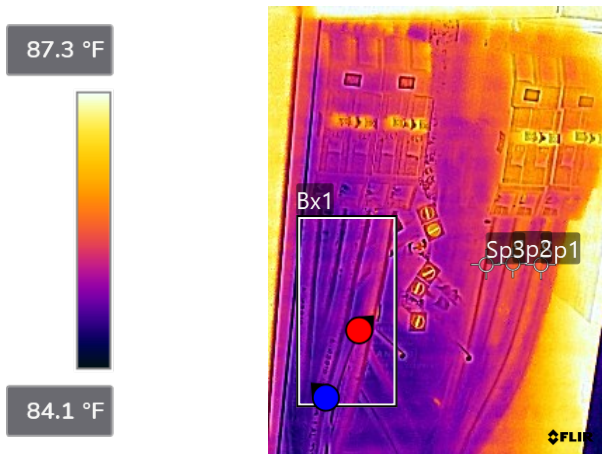
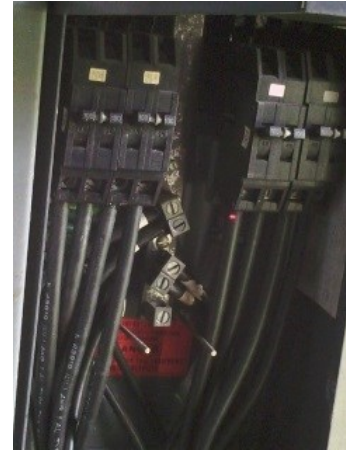
FLIR1716.jpg

Building 400 - Main Electrical Room - Main #1 - Units' Feeders and Main Circuit Breakers

Repairs Are Not Required

Deficiencies were not observed at this equipment at the time of the inspection.

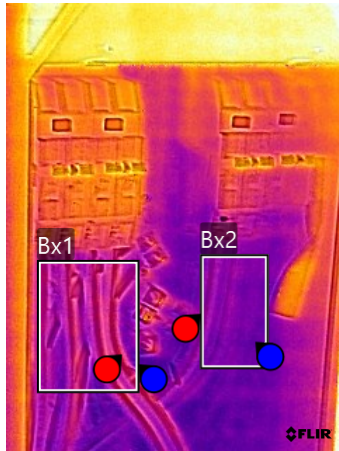
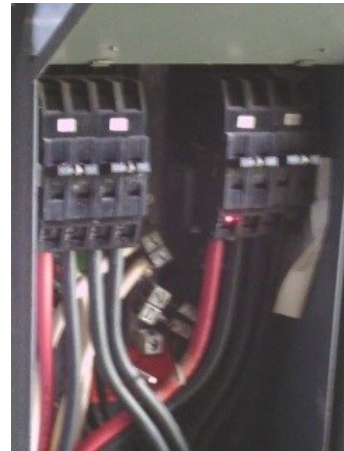
FLIR1718.jpg

Repairs Are Not Required

Deficiencies were not observed at this equipment at the time of the inspection.

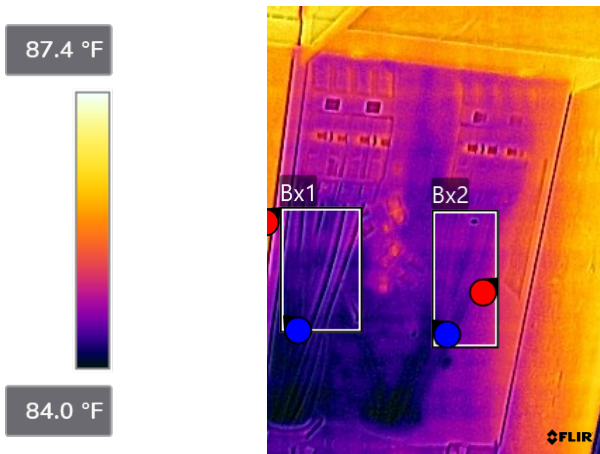
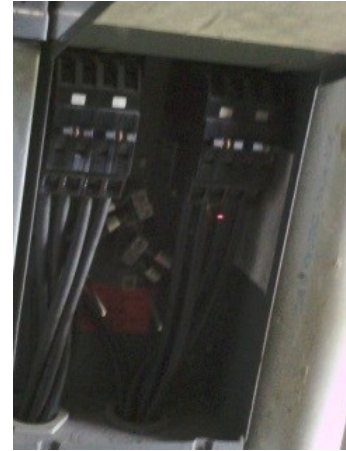
FLIR1720.jpg

Building 400 - Main Electrical Room - Main #1 - Units' Feeders and Main Circuit Breakers

Repairs Are Not Required

Deficiencies were not observed at this equipment at the time of the inspection.

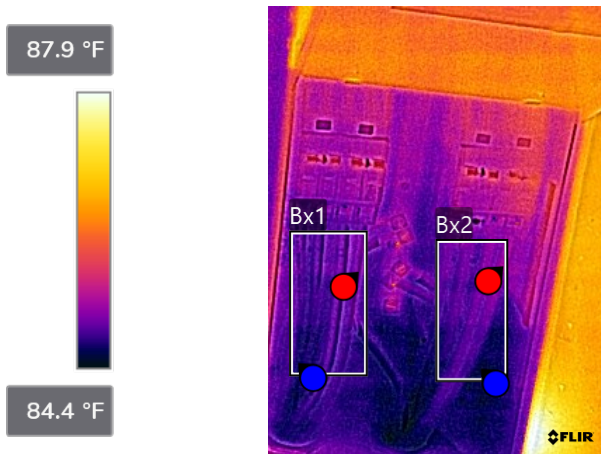
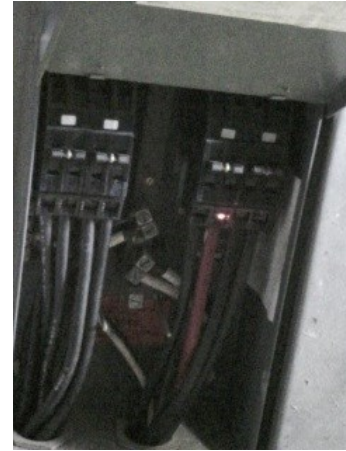
FLIR1722.jpg

Building 400 - Main Electrical Room - Main #1 - Units' Feeders and Main Circuit Breakers

Repairs Are Not Required

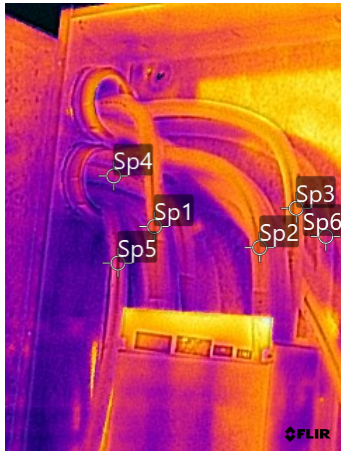
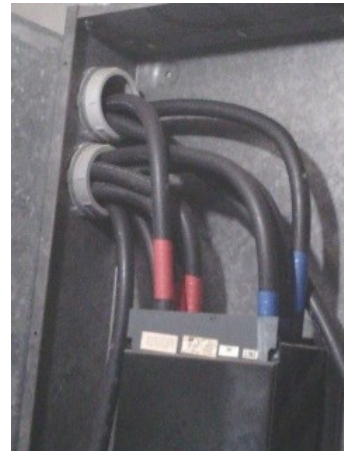
FLIR1724.jpg

Repairs Are Not Required

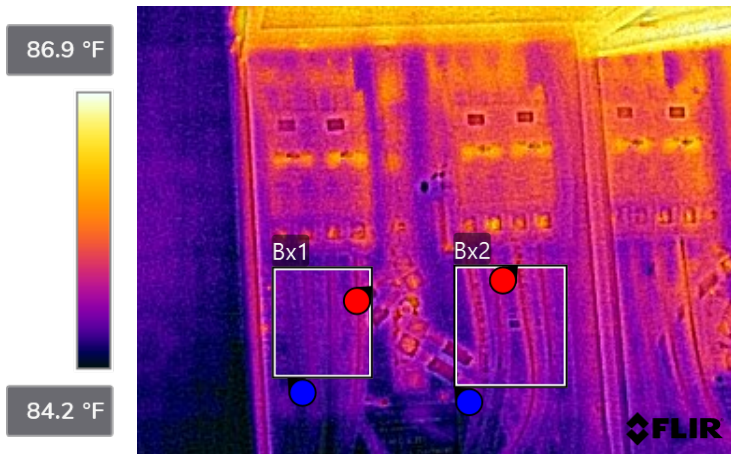
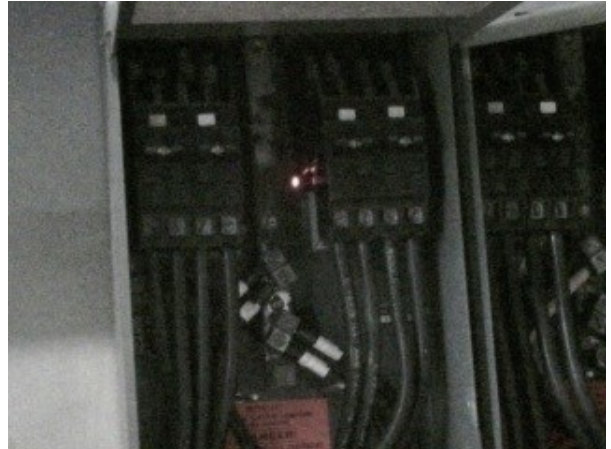
FLIR1730.jpg

Building 400 - Main Electrical Room - Main #2 - Units' Feeders and Main Circuit Breakers

Repairs Are Not Required

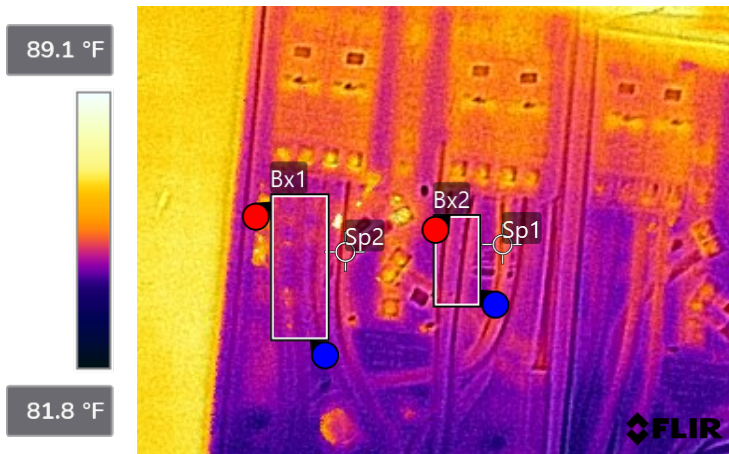
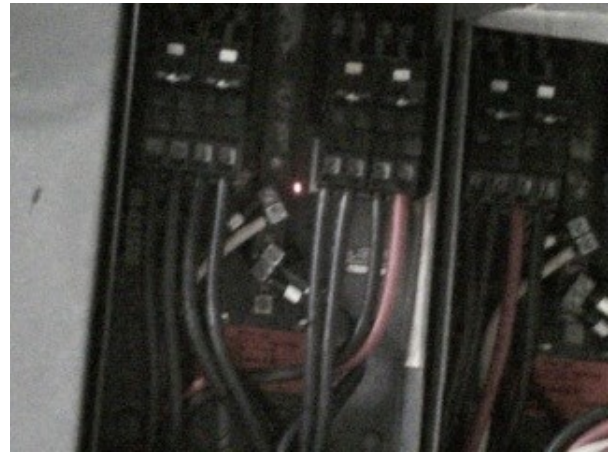
FLIR1732.jpg

Building 400 - Main Electrical Room - Main #2 - Units' Feeders and Main Circuit Breakers

Repairs Are Not Required

Deficiencies were not observed at this equipment at the time of the inspection.

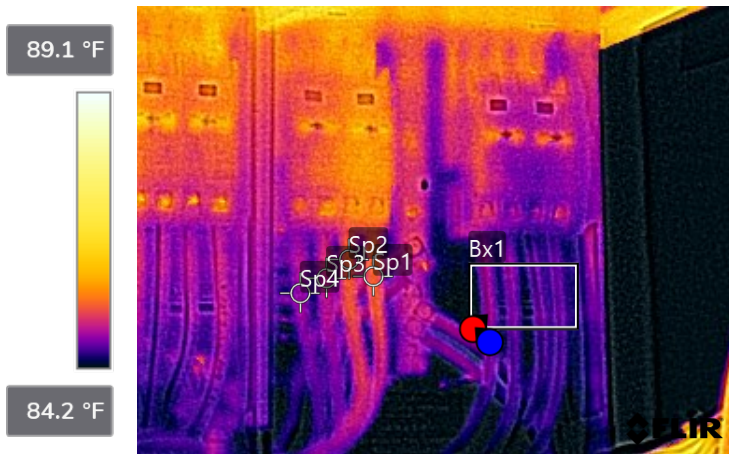
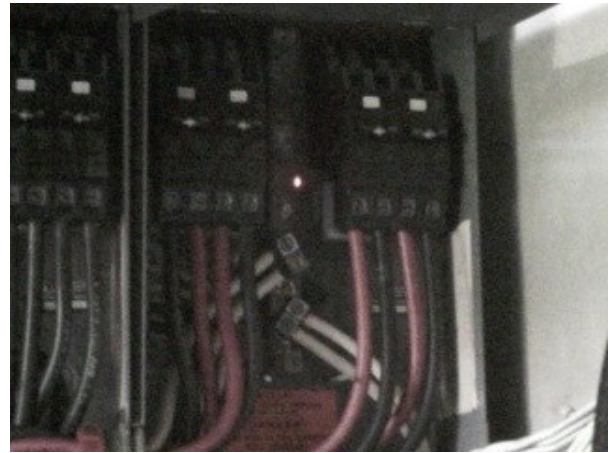
FLIR1736.jpg

Building 400 - Main Electrical Room - Main #2 - Units' Feeders and Main Circuit Breakers

Repairs Are Not Required

Deficiencies were not observed at this equipment at the time of the inspection.

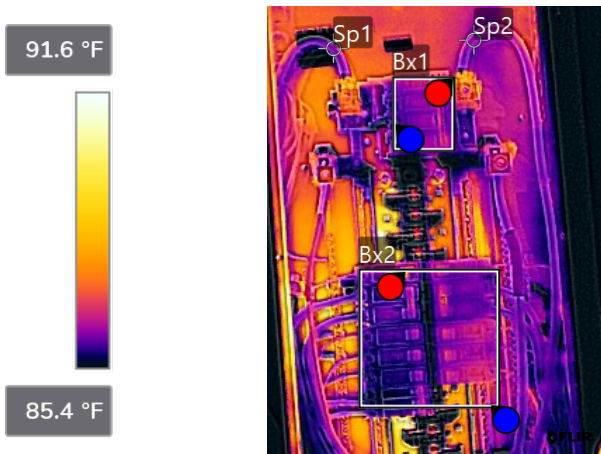
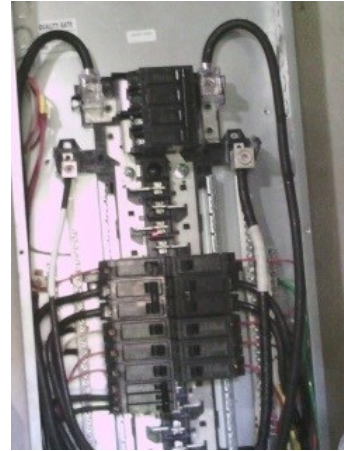
FLIR1740.jpg

Building 400 - Main Electrical Room - House Panel #1

Repairs Are Not Required

Deficiencies were not observed at this equipment at the time of the inspection.

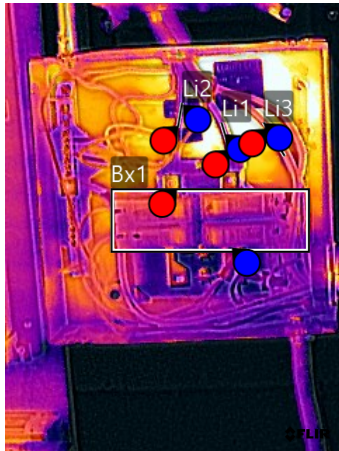
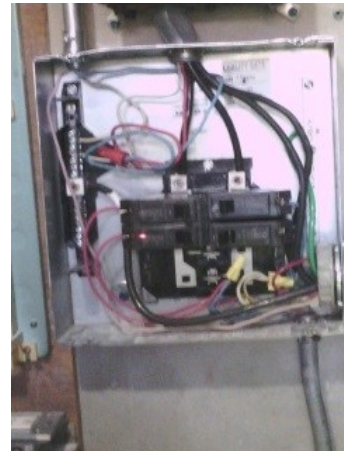
FLIR1738.jpg

Repairs Are Not Required

Deficiencies were not observed at this equipment at the time of the inspection.

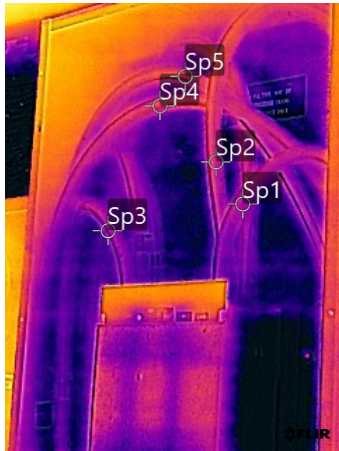
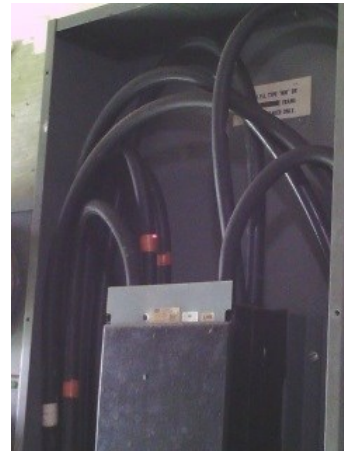
FLIR1742.jpg

Repairs Are Not Required

Deficiencies were not observed at this equipment at the time of the inspection.

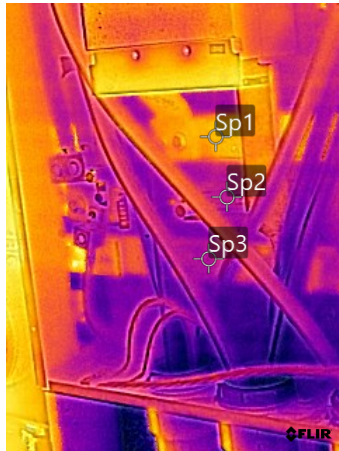
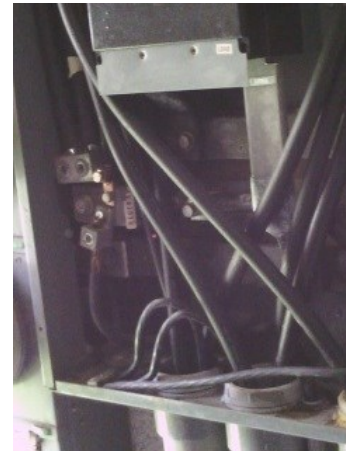
FLIR1744.jpg

Repairs Are Not Required

Deficiencies were not observed at this equipment at the time of the inspection.

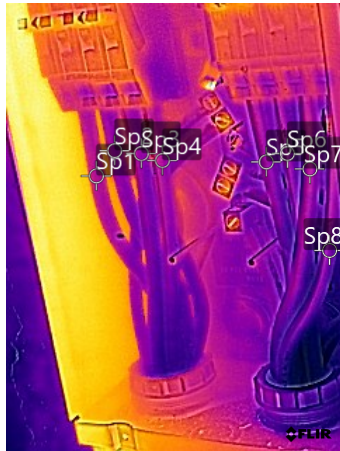
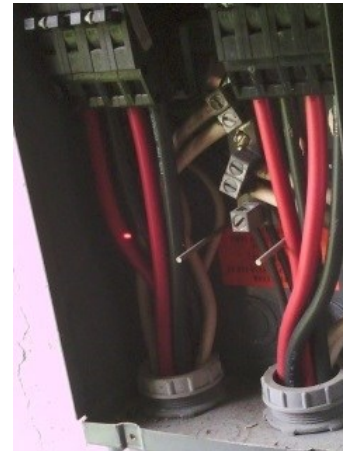
FLIR1748.jpg

Repairs Are Not Required

Deficiencies were not observed at this equipment at the time of the inspection.

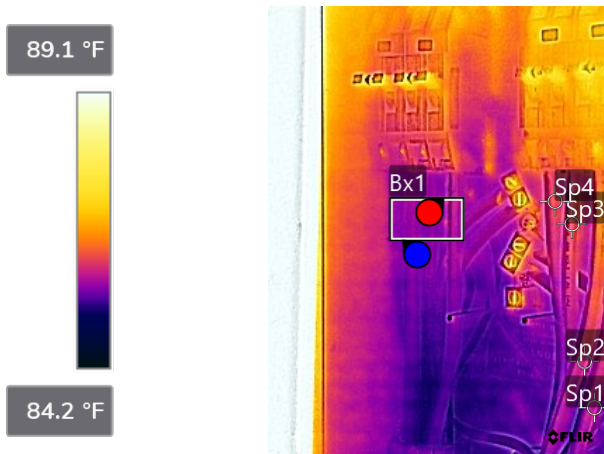
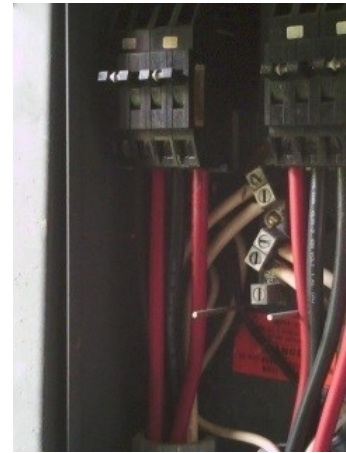
FLIR1754.jpg

Building 500 - Main Electrical Room - Main #1 - Units' Feeders and Main Circuit Breakers

Repairs Are Not Required

Deficiencies were not observed at this equipment at the time of the inspection.

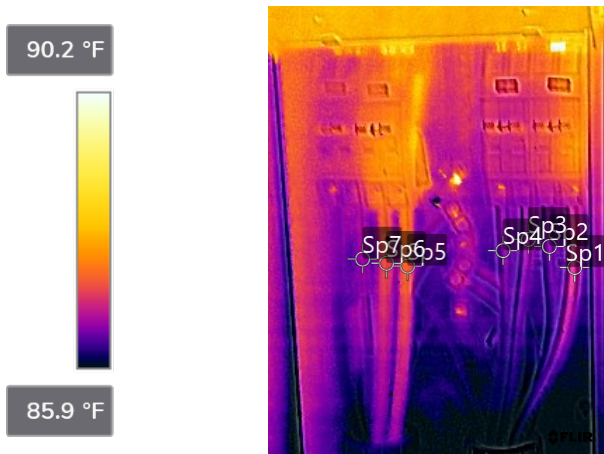
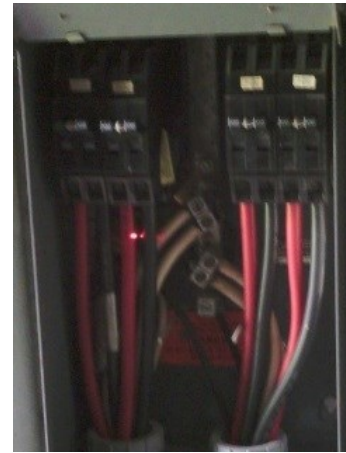
FLIR1756.jpg

Building 500 - Main Electrical Room - Main #1 - Units' Feeders and Main Circuit Breakers

Repairs Are Not Required

Deficiencies were not observed at this equipment at the time of the inspection.

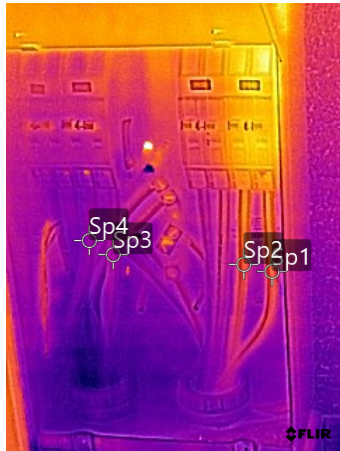
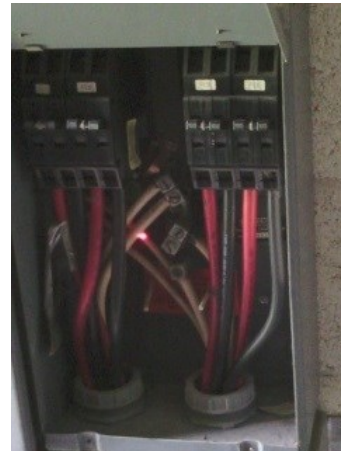
FLIR1758.jpg

Building 500 - Main Electrical Room - Main #1 - Units' Feeders and Main Circuit Breakers

Repairs Are Not Required

The minor difference in color and temperature observed in Sp1 and Sp2 is a result of the temperature measured at the time of the inspection.

Deficiencies were not observed with this equipment at the time of the inspection.

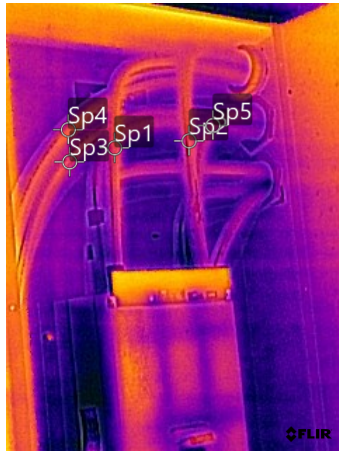
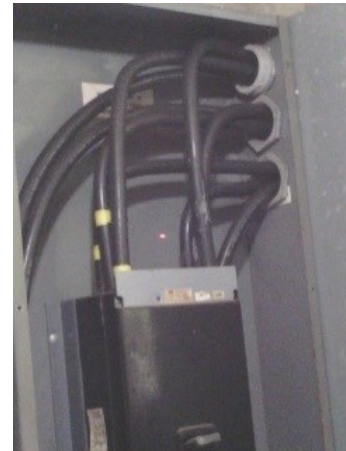
FLIR1768.jpg

Repairs Are Not Required

Deficiencies were not observed at this equipment at the time of the inspection.

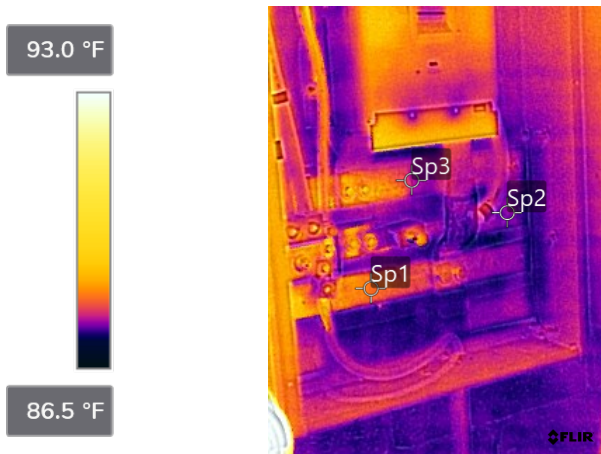
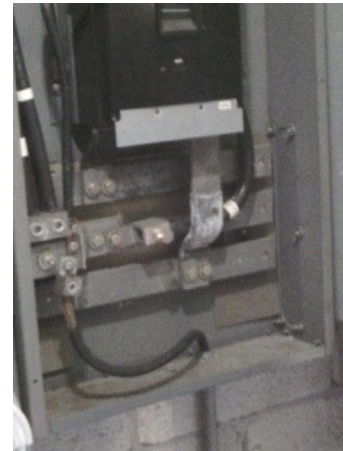
FLIR1772.jpg

Building 500 - Main Electrical Room - Main Service Disconnect #2 - Circuit Breaker and Distribution Bars

Repairs Are Not Required

Deficiencies were not observed at this equipment at the time of the inspection.

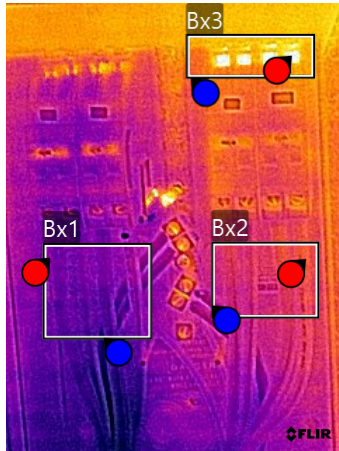
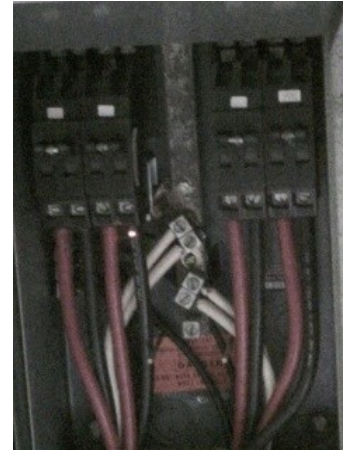
FLIR1774.jpg

Minor Repair is Required

Minor Repair is Required
High temperature was observed in the lugs connections at the circuit breakers.
The electrical contractor shall tight lugs and clean connection.

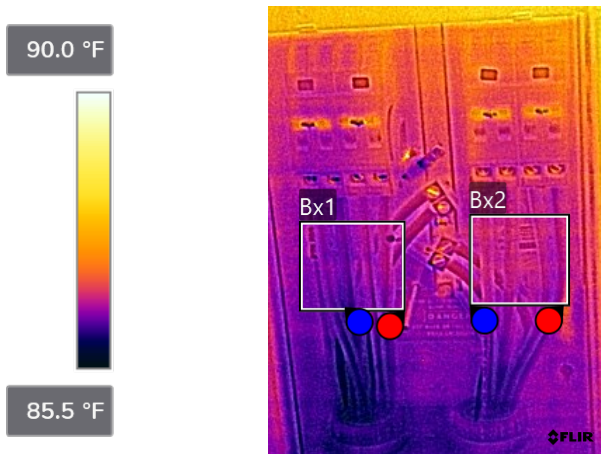
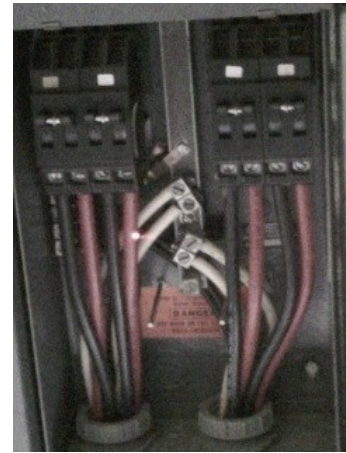
FLIR1776.jpg

Building 500 - Main Electrical Room - Main #2 - Units' Feeders and Main Circuit Breakers

Repairs Are Not Required

Deficiencies were not observed at this equipment at the time of the inspection.

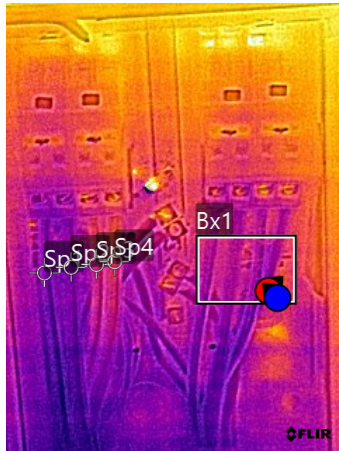
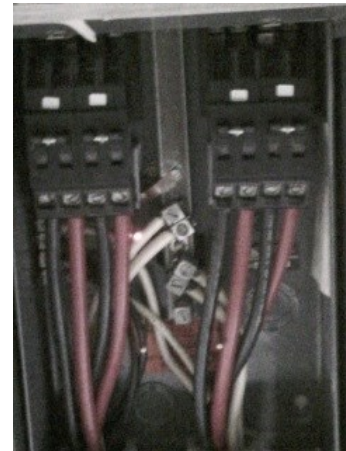
FLIR1778.jpg

Repairs Are Not Required

Deficiencies were not observed at this equipment at the time of the inspection.
