50-Year Recertification Thermography Report

Meadow Condominium Association, Inc
377 SW 56th Ave, Margate, FL 33068

MEADOWS CONDOMINIUM

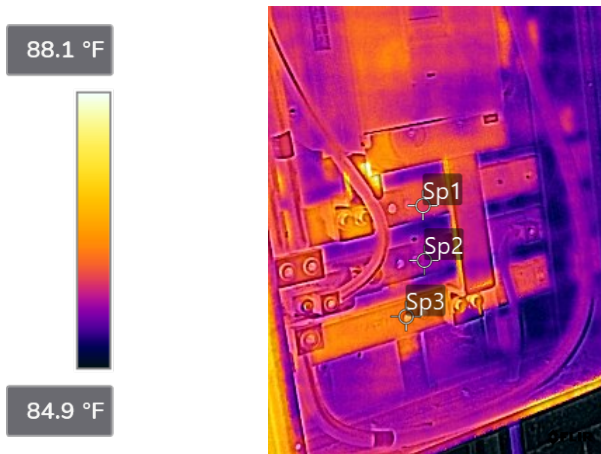
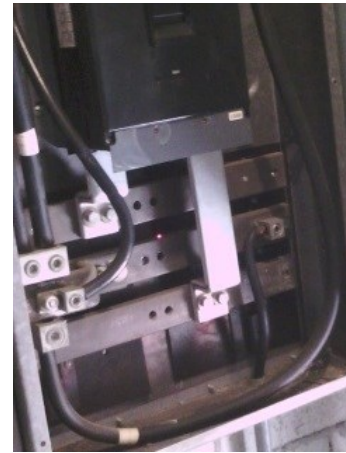
FLIR1788.jpg

Building 600 - Main Electrical Room - Main Service Disconnect #1 - Circuit Breaker and Distribution Bars

Repairs Are Not Required

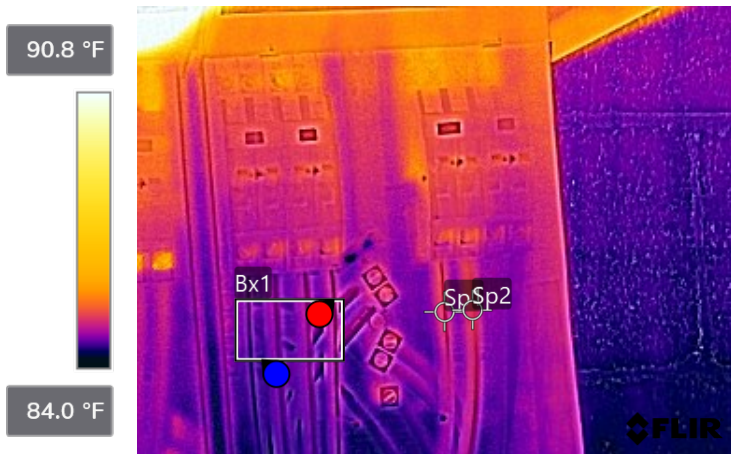
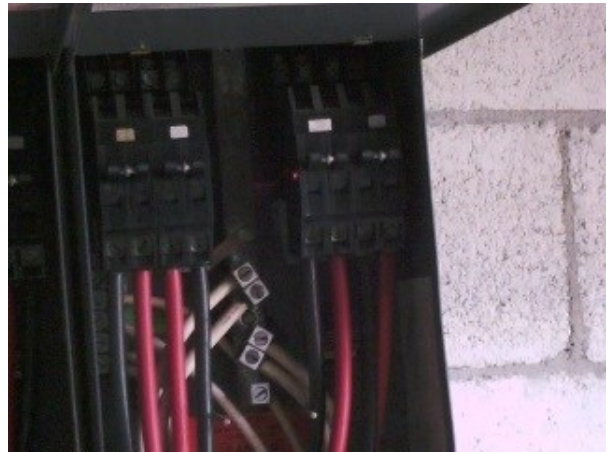
Building 600 - Main Electrical Room - Main #1 - Units' Feeders and Main Circuit Breakers

Repairs Are Not Required

Deficiencies were not observed at this equipment at the time of the inspection.

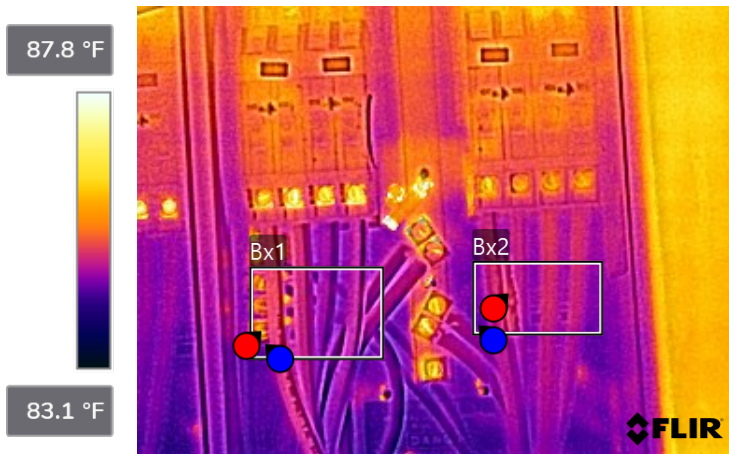
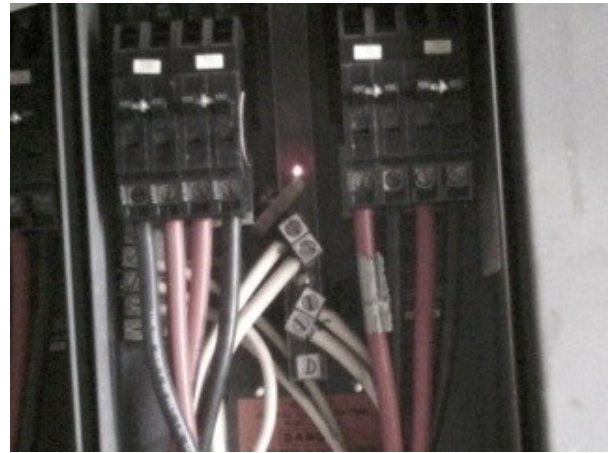
Building 600 - Main Electrical Room - Main #1 - Units' Feeders and Main Circuit Breakers

Repairs Are Not Required

Deficiencies were not observed at this equipment at the time of the inspection.

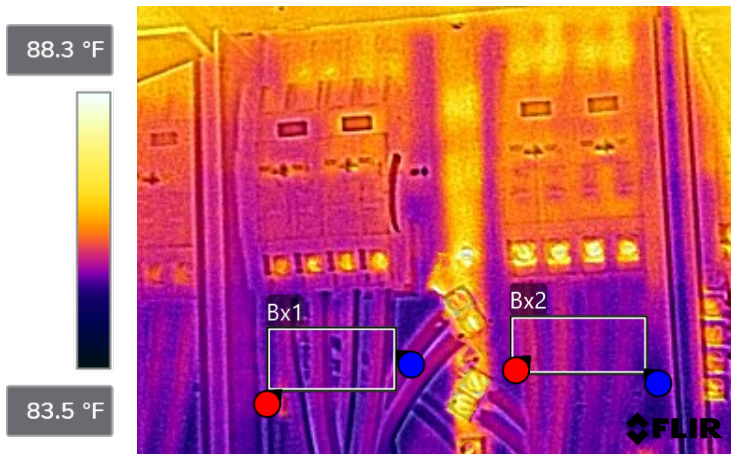
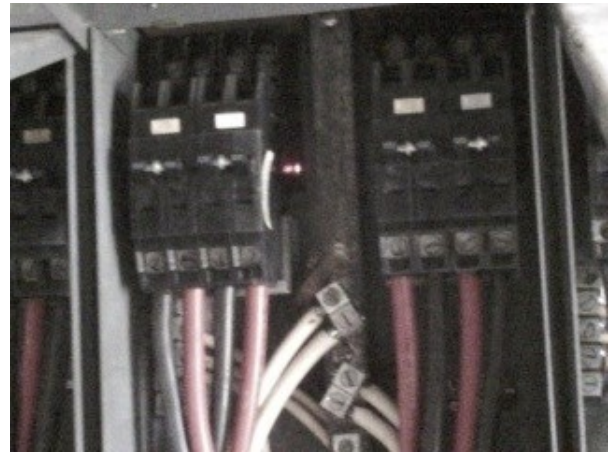
Building 600 - Main Electrical Room - Main #1 - Units' Feeders and Main Circuit Breakers

Repairs Are Not Required

Deficiencies were not observed at this equipment at the time of the inspection.

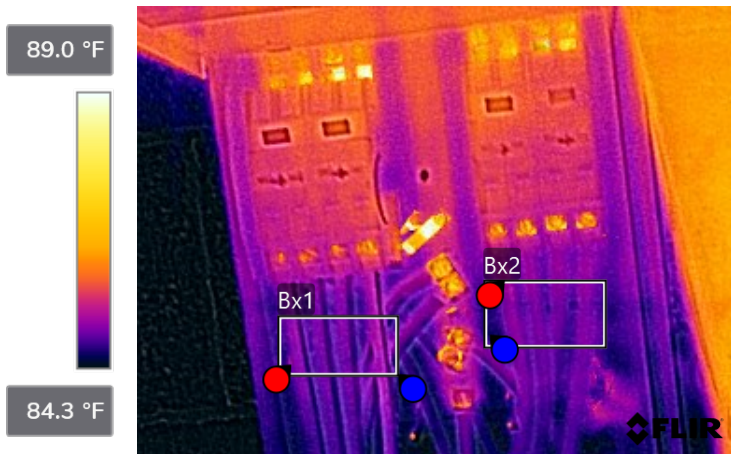
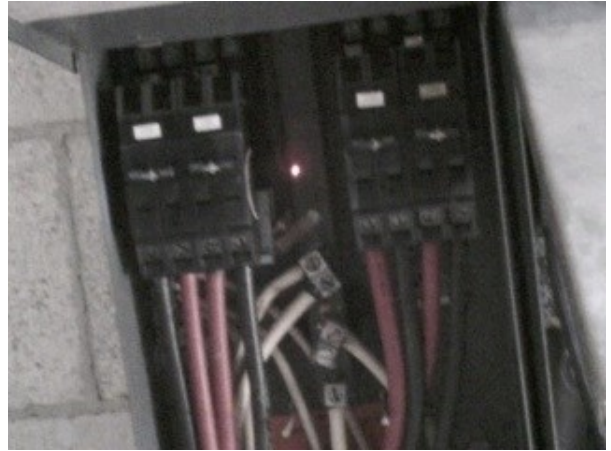
Building 600 - Main Electrical Room - Main #1 - Units' Feeders and Main Circuit Breakers

Repairs Are Not Required

Deficiencies were not observed at this equipment at the time of the inspection.

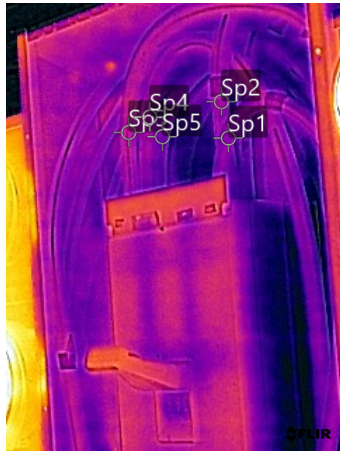
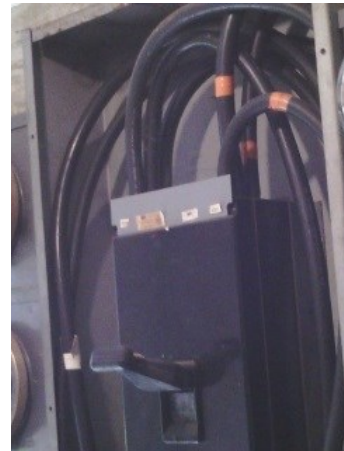
Repairs Are Not Required

Deficiencies were not observed at this equipment at the time of the inspection.

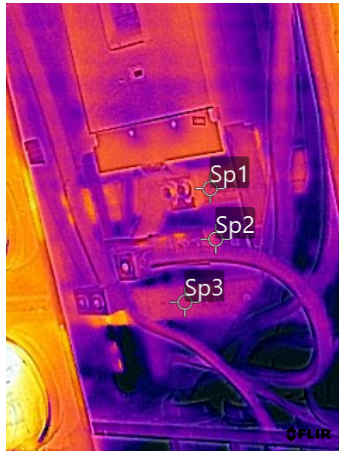
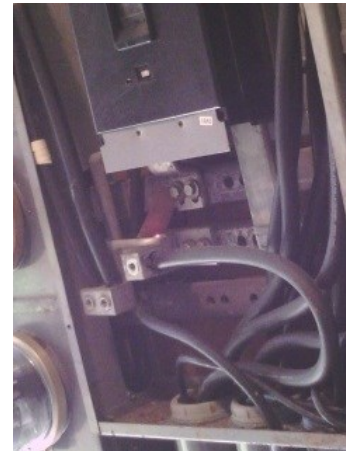
Repairs Are Not Required

Deficiencies were not observed at this equipment at the time of the inspection.

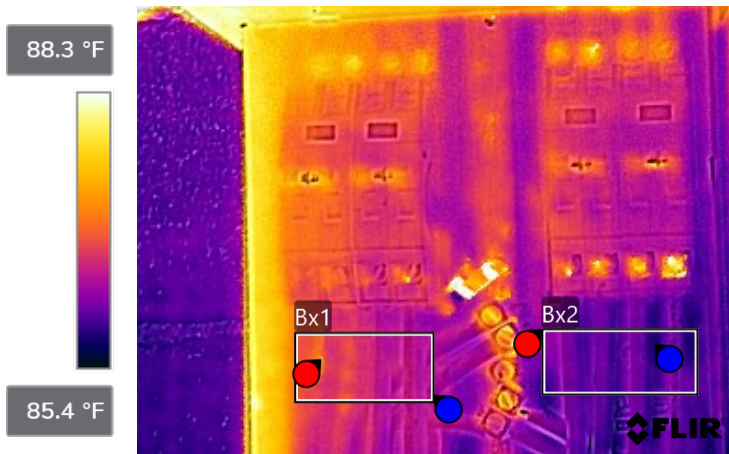
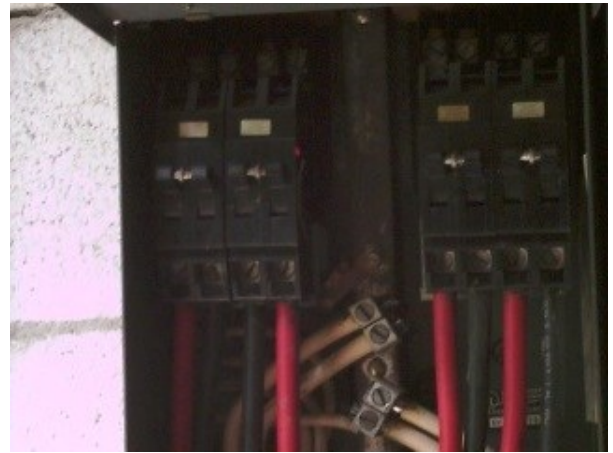
Building 600 - Main Electrical Room - Main #2 - Units' Feeders and Main Circuit Breakers

Repairs Are Not Required

Deficiencies were not observed at this equipment at the time of the inspection.

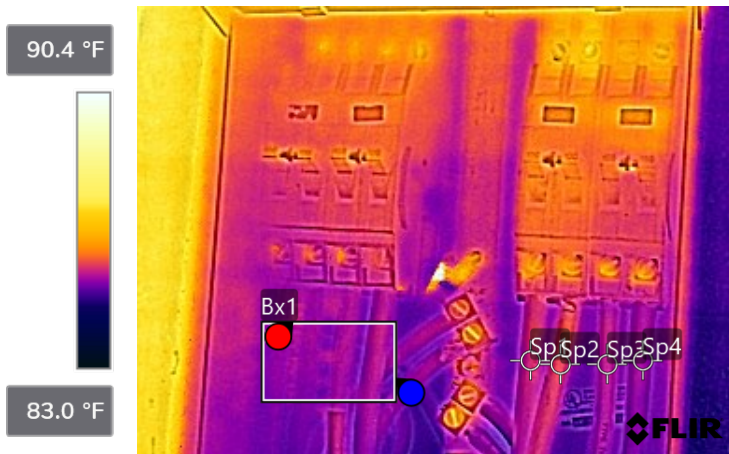
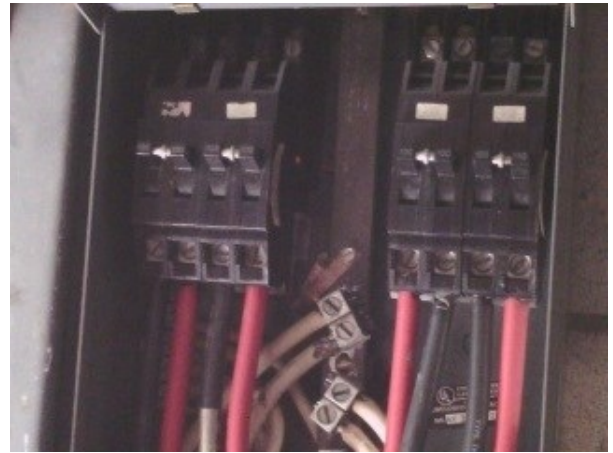
Building 600 - Main Electrical Room - Main #2 - Units' Feeders and Main Circuit Breakers

Repairs Are Not Required

Deficiencies were not observed at this equipment at the time of the inspection.

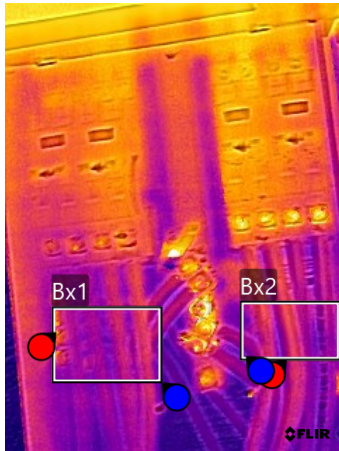
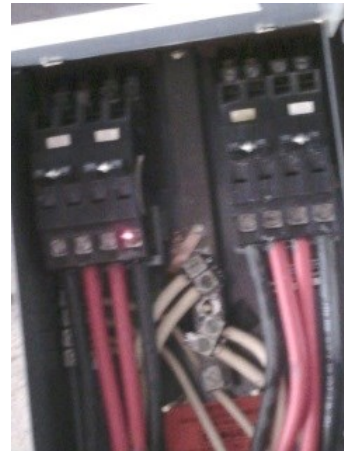
Repairs Are Not Required

Deficiencies were not observed at this equipment at the time of the inspection.

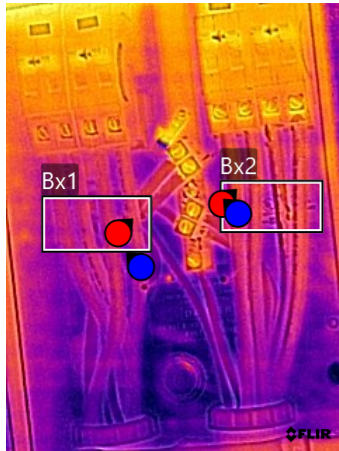
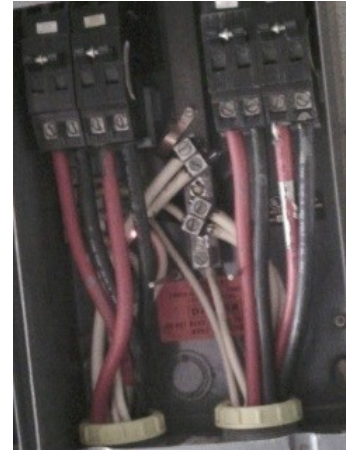
Repairs Are Not Required

Deficiencies were not observed at this equipment at the time of the inspection.

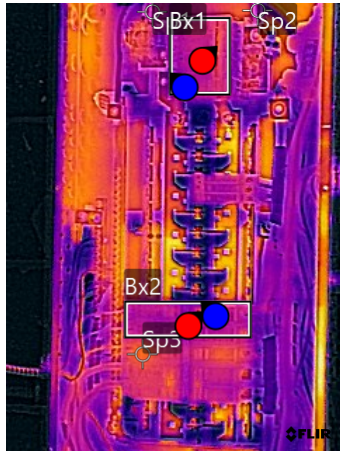
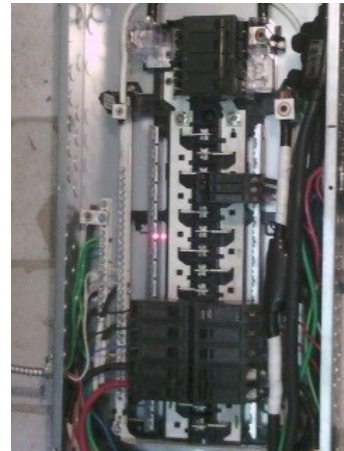
Repairs Are Not Required

Deficiencies were not observed at this equipment at the time of the inspection.

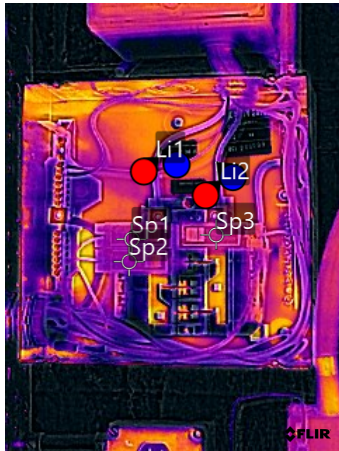
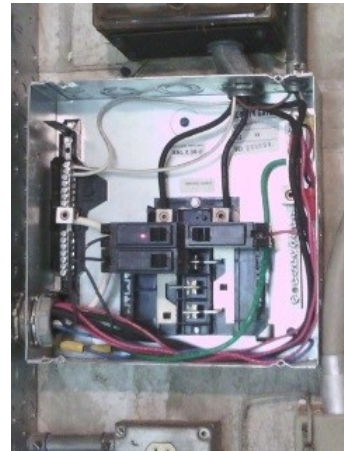
Repairs Are Not Required

Deficiencies were not observed at this equipment at the time of the inspection.

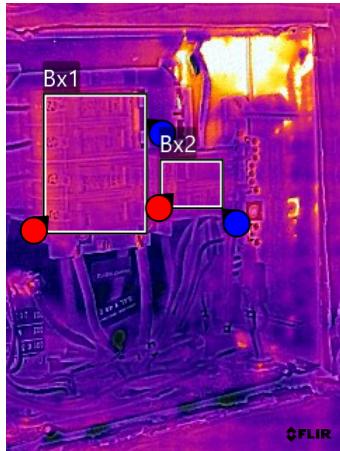
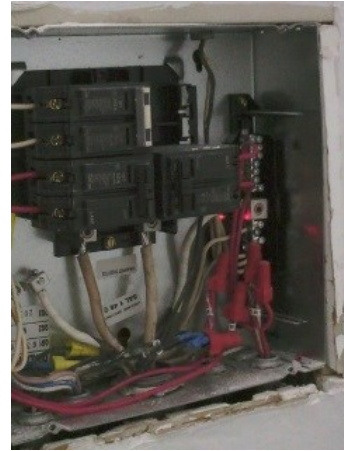
Repairs Are Not Required

Deficiencies were not observed at this equipment at the time of the inspection.

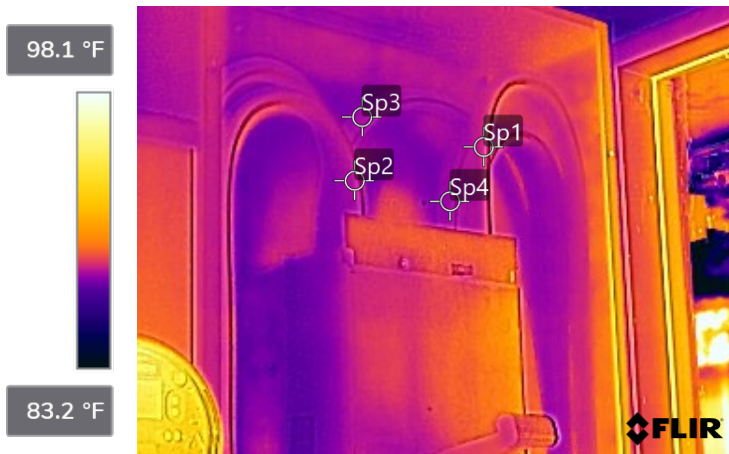
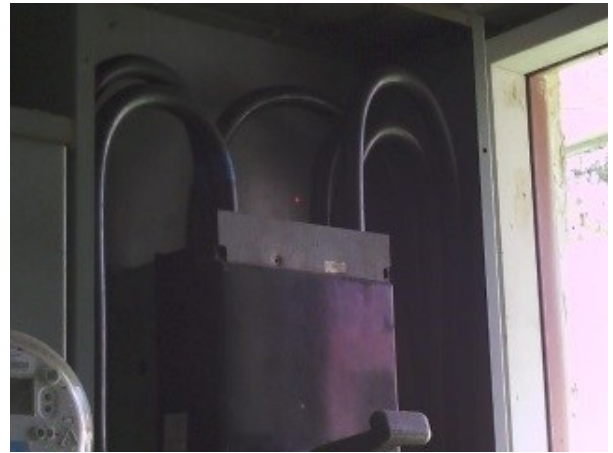
Building 700 - Main Electrical Room - Main Service Disconnect #1 - Fedders and Circuit Breaker

Repairs Are Not Required

Deficiencies were not observed at this equipment at the time of the inspection.

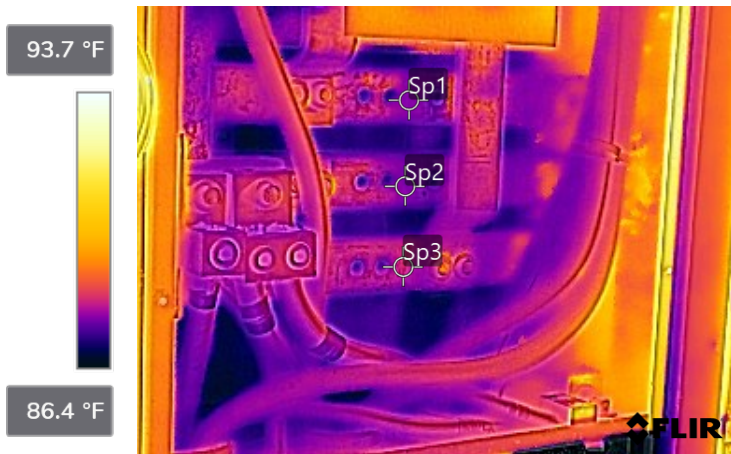
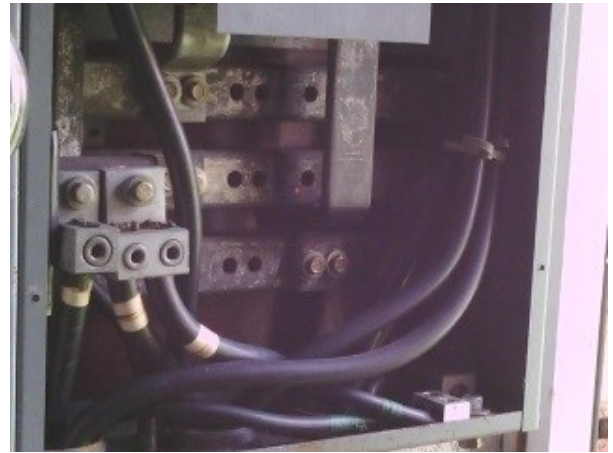
Building 700 - Main Electrical Room - Main Service Disconnect #1 - Circuit Breaker and Distribution Bars

Repairs Are Not Required

Deficiencies were not observed at this equipment at the time of the inspection.

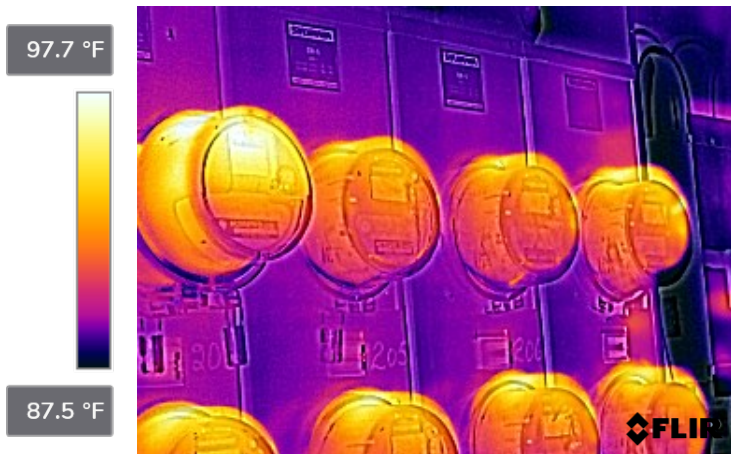
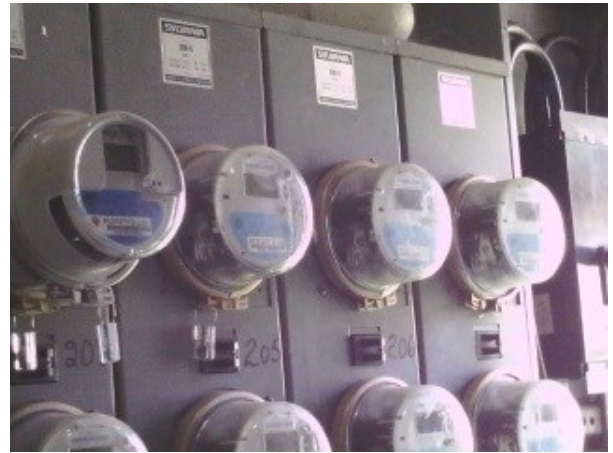
Building 700 - Main Electrical Room - Main Service Disconnect #1 - Unit's Main Breaker and Meters

Repairs Are Not Required

Deficiencies were not observed at this equipment at the time of the inspection.

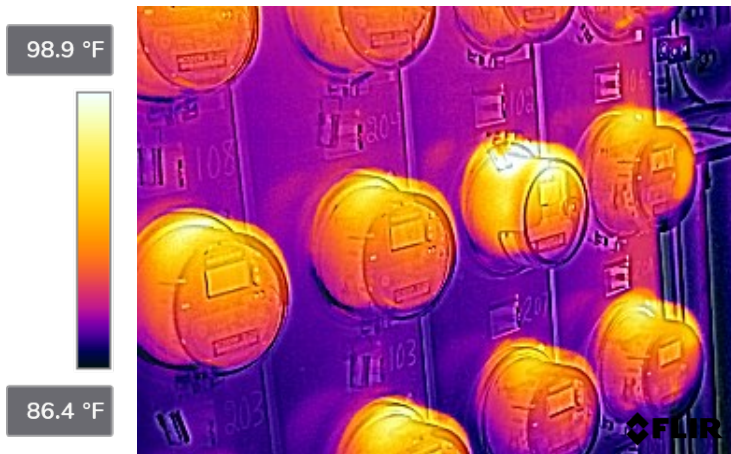
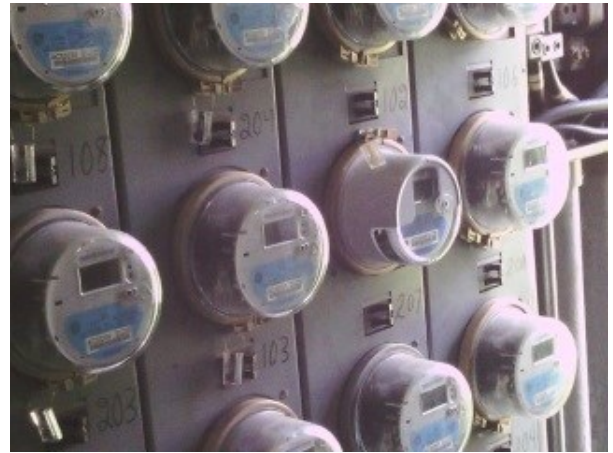
Building 700 - Main Electrical Room - Main Service Disconnect #1 - Unit's Main Breaker and Meters

Repairs Are Not Required

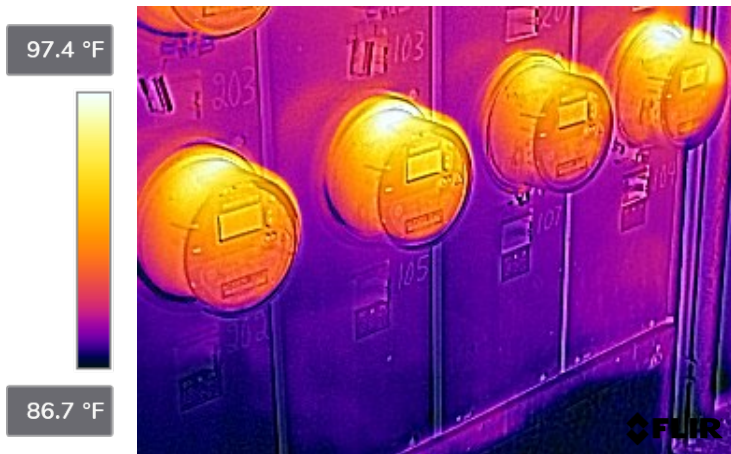
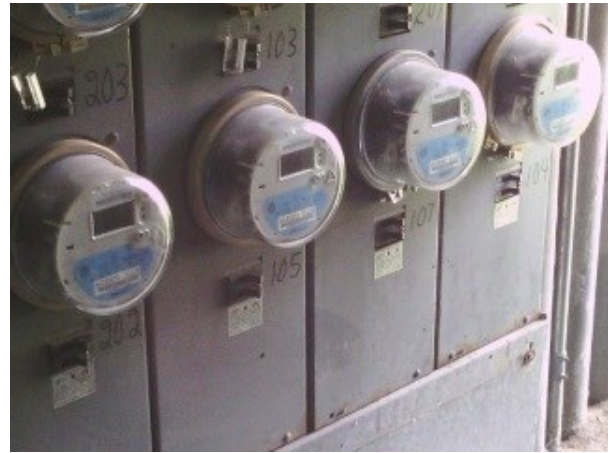
Building 700 - Main Electrical Room - Main Service Disconnect #1 - Unit's Main Breaker and Meters

Repairs Are Not Required

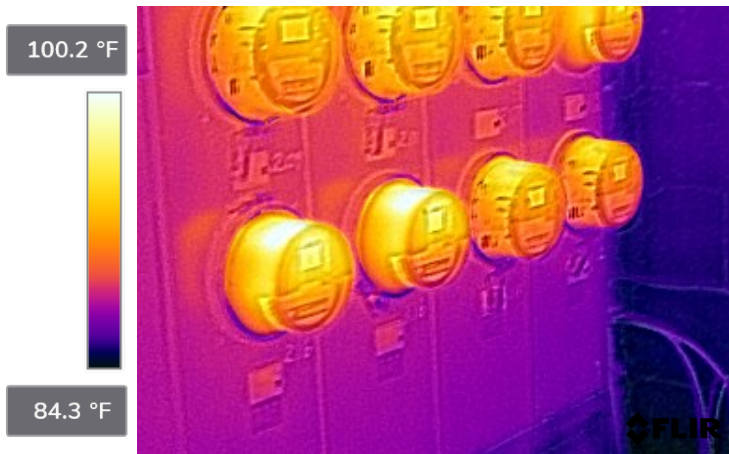
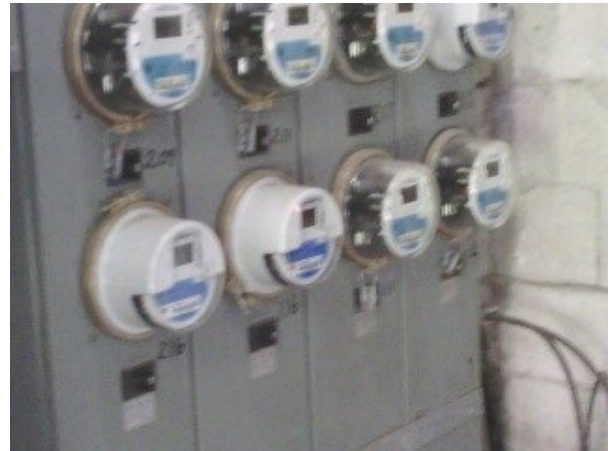
FLIR1856.jpg

Building 700 - Main Electrical Room - Main Service Disconnect #2 - Unit's Main Breaker and Meters

Repairs Are Not Required

Deficiencies were not observed at this equipment at the time of the inspection.

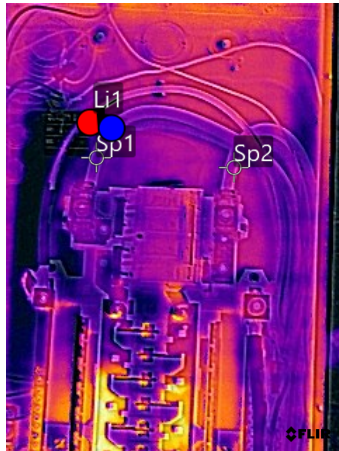
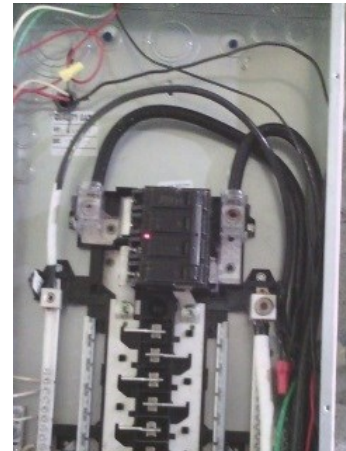
FLIR1858.jpg

Repairs Are Not Required

Deficiencies were not observed at this equipment at the time of the inspection.

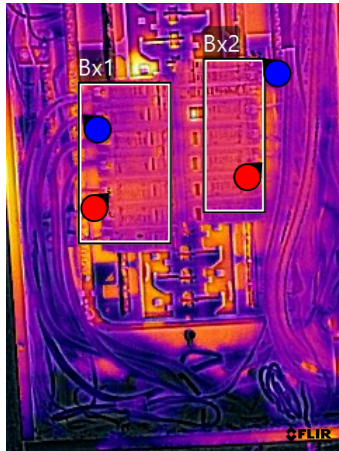
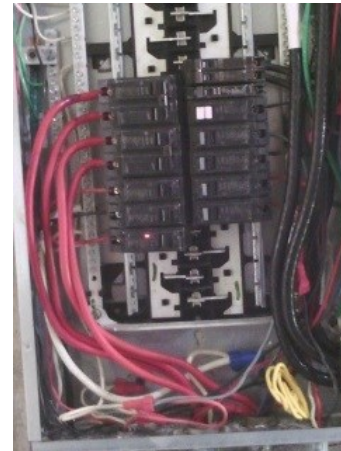
FLIR1860.jpg

Repairs Are Not Required

Deficiencies were not observed at this equipment at the time of the inspection.

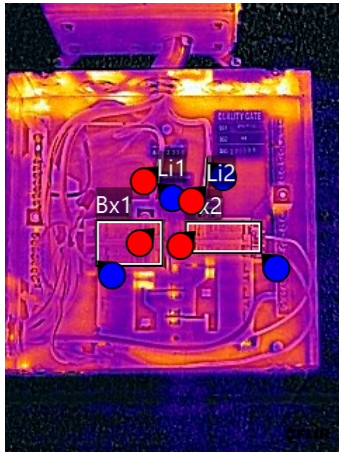
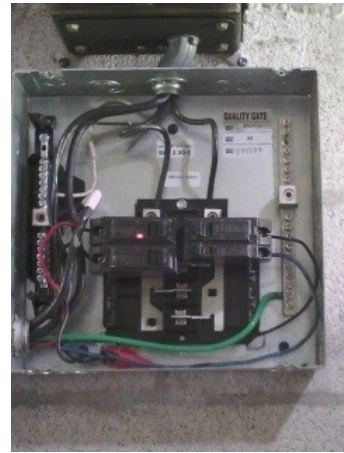
FLIR1862.jpg

Repairs Are Not Required

Deficiencies were not observed at this equipment at the time of the inspection.

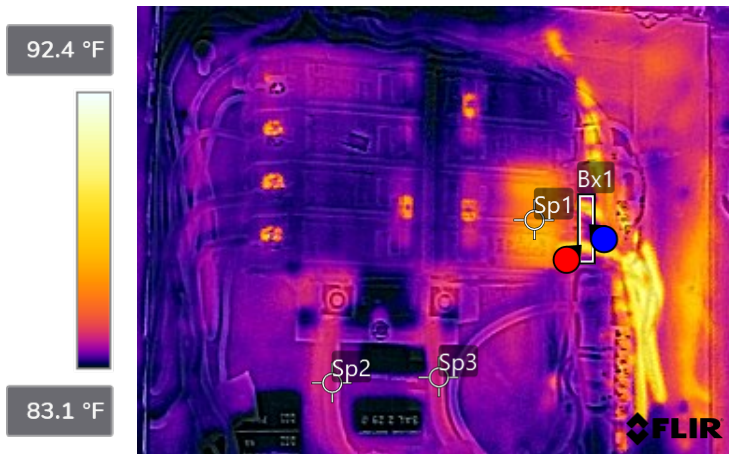
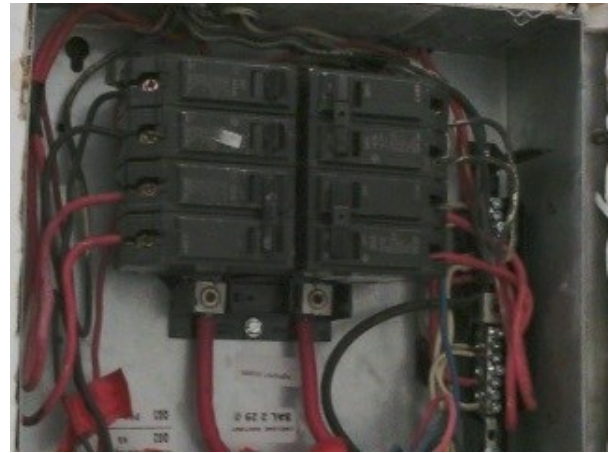
FLIR1874.jpg

Building 700 - Laundry Room - Panel

Repairs Are Not Required

The temperature observed in the 2P-30A circuit breaker is the result of the consumption measured at the time of the inspection.
 Phase A: 4 Amp
 Phase B: 4 Amp
 Deficiencies were not observed with this equipment at the time of the inspection.

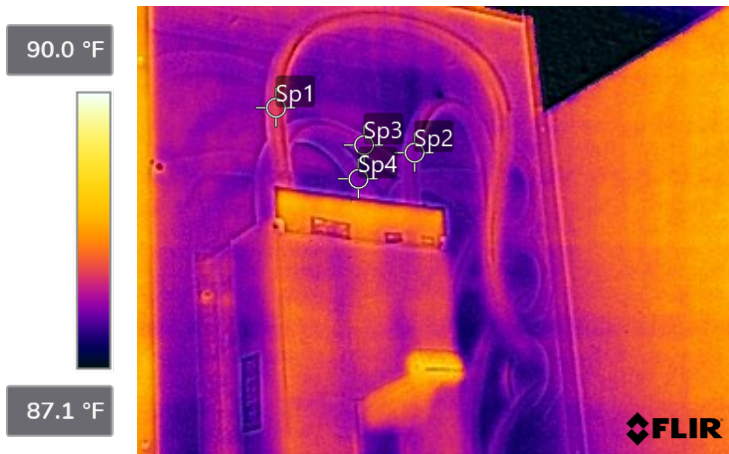
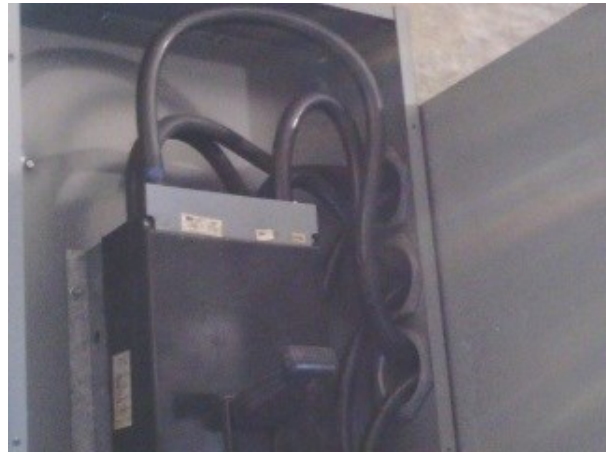
FLIR1880.jpg

Building 800 - Main Electrical Room - Main Service Disconnect #1 - Fedders and Circuit Breaker

Repairs Are Not Required

Deficiencies were not observed at this equipment at the time of the inspection.

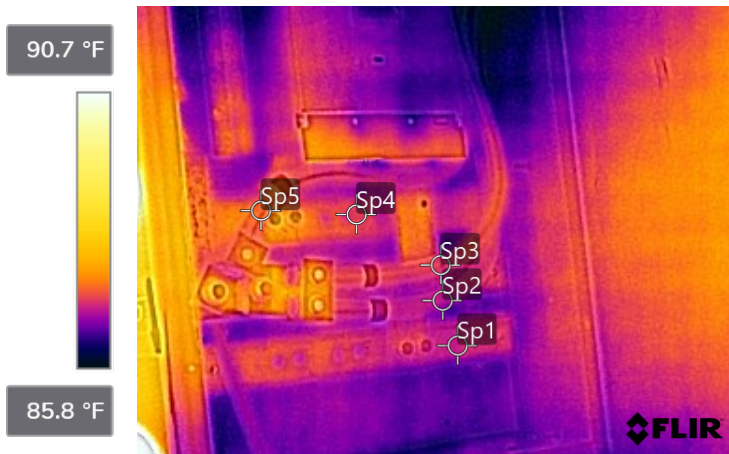
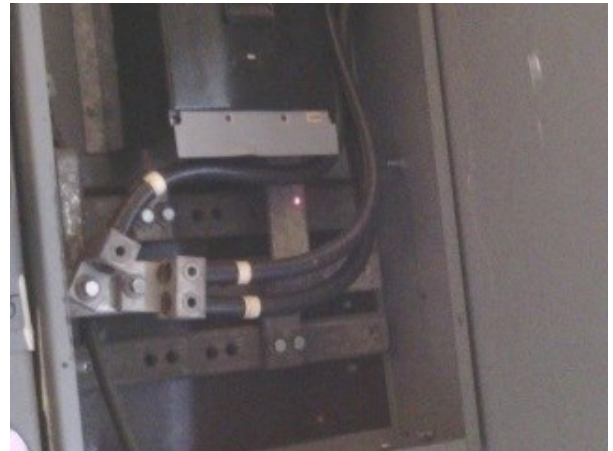
FLIR1884.jpg

Building 800 - Main Electrical Room - Main Service Disconnect #1 - Circuit Breaker and Distribution Bars

Repairs Are Not Required

Deficiencies were not observed at this equipment at the time of the inspection.

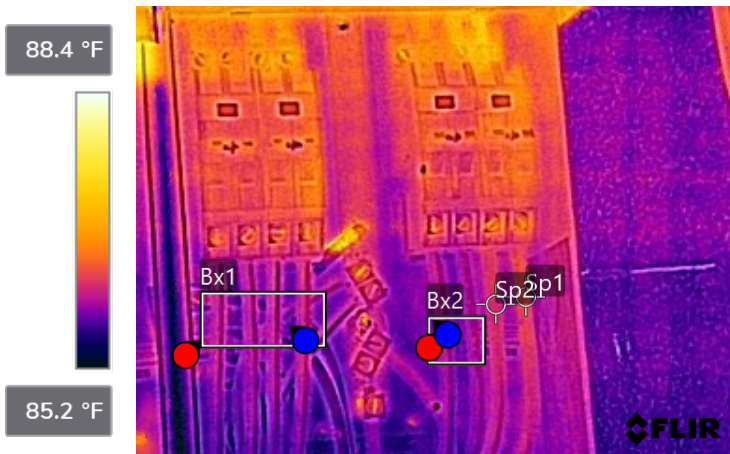
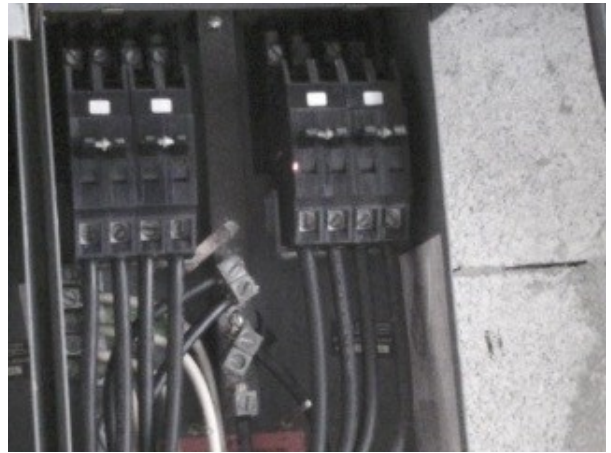
FLIR1886.jpg

Building 800 - Main Electrical Room - Main #1 - Units' Feeders and Main Circuit Breakers

Repairs Are Not Required

Deficiencies were not observed at this equipment at the time of the inspection.

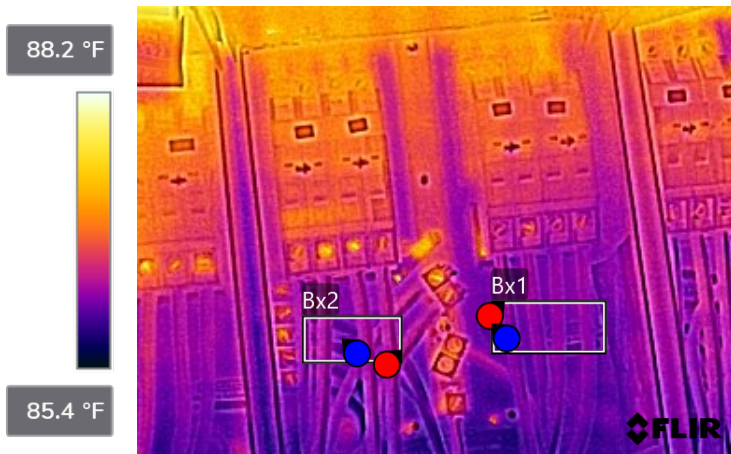
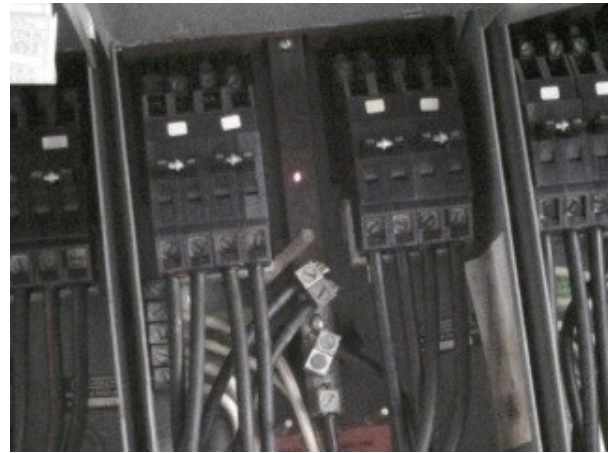
FLIR1888.jpg

Building 800 - Main Electrical Room - Main #1 - Units' Feeders and Main Circuit Breakers

Repairs Are Not Required

Deficiencies were not observed at this equipment at the time of the inspection.

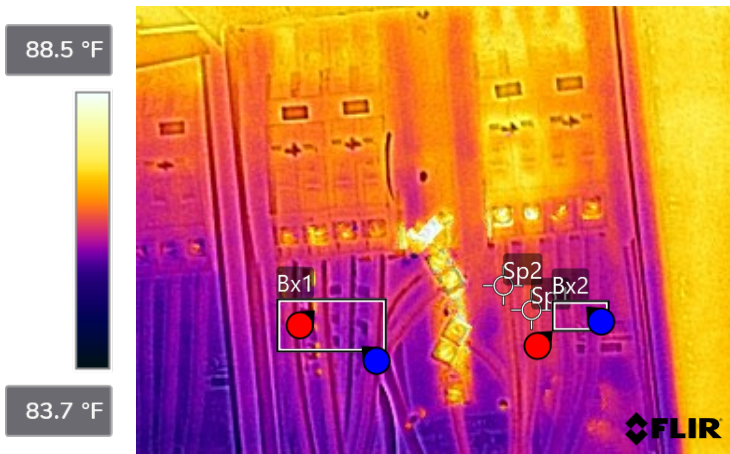
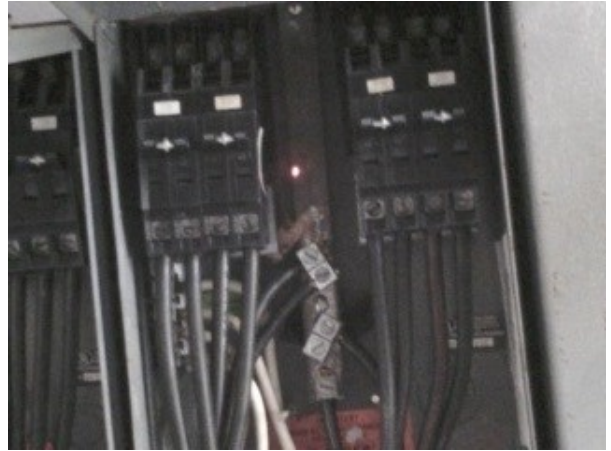
FLIR1890.jpg

Building 800 - Main Electrical Room - Main #1 - Units' Feeders and Main Circuit Breakers

Repairs Are Not Required

Deficiencies were not observed at this equipment at the time of the inspection.

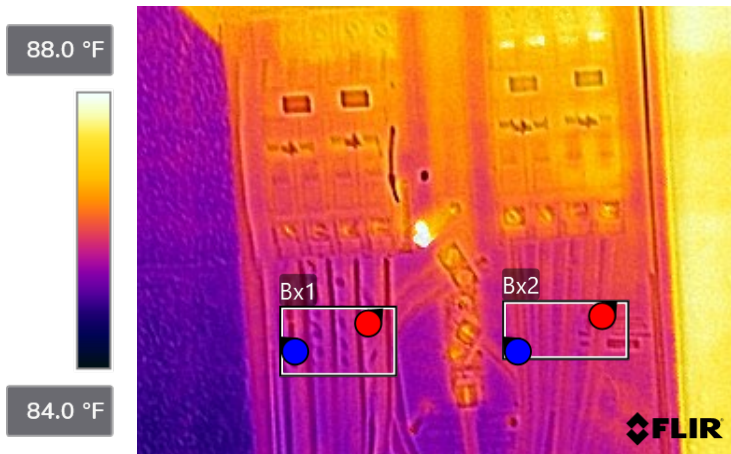
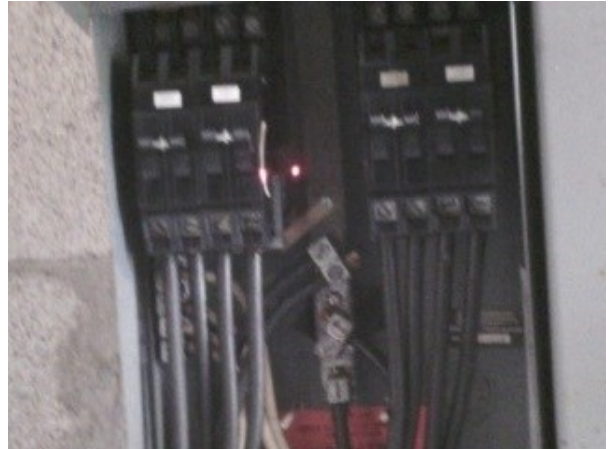
FLIR1894.jpg

Building 800 - Main Electrical Room - Main #1 - Units' Feeders and Main Circuit Breakers

Repairs Are Not Required

Deficiencies were not observed at this equipment at the time of the inspection.

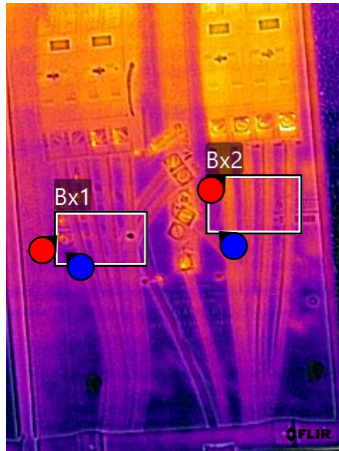
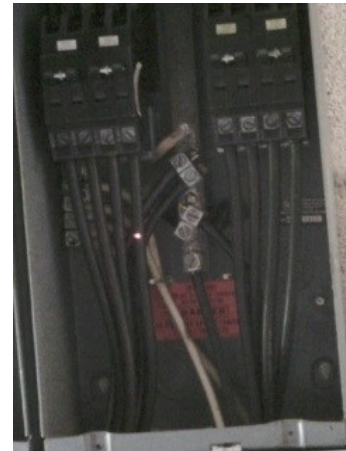
FLIR1900.jpg

Repairs Are Not Required

Deficiencies were not observed at this equipment at the time of the inspection.

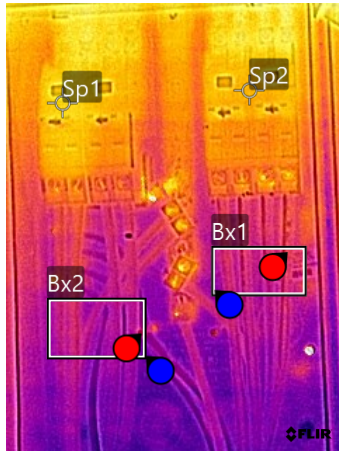
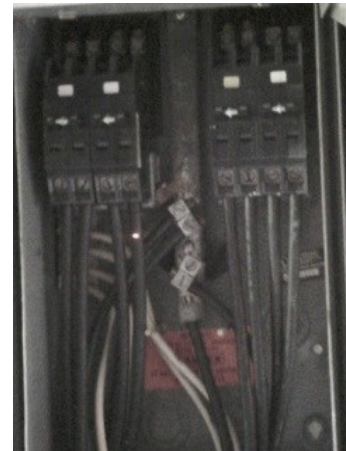
FLIR1902.jpg

Building 800 - Main Electrical Room - Main #2 - Units' Feeders and Main Circuit Breakers

Repairs Are Not Required

Deficiencies were not observed at this equipment at the time of the inspection.

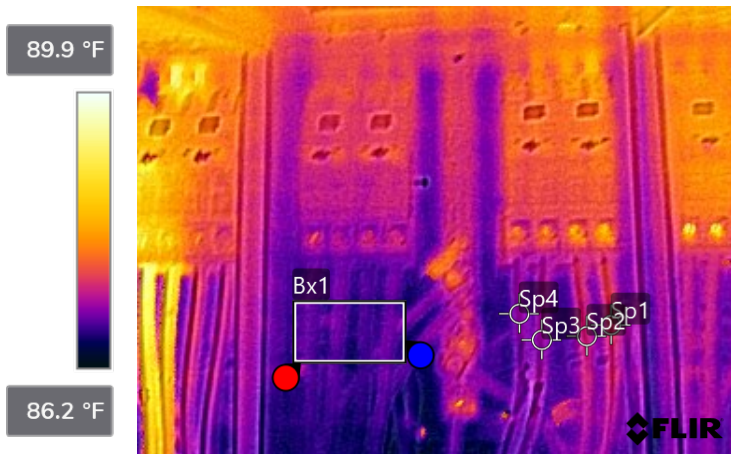
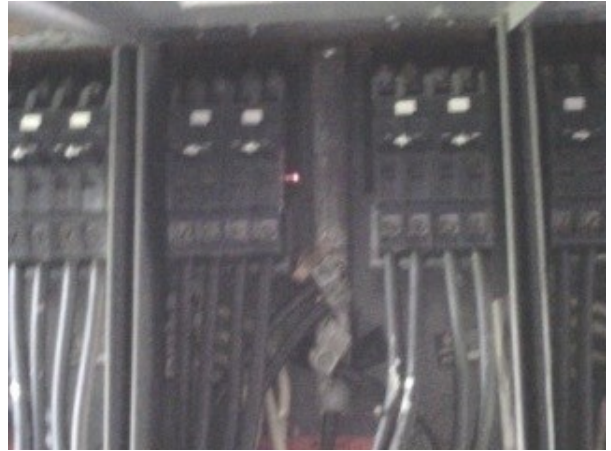
FLIR1912.jpg

Building 800 - Main Electrical Room - Main #2 - Units' Feeders and Main Circuit Breakers

Repairs Are Not Required

Deficiencies were not observed at this equipment at the time of the inspection.

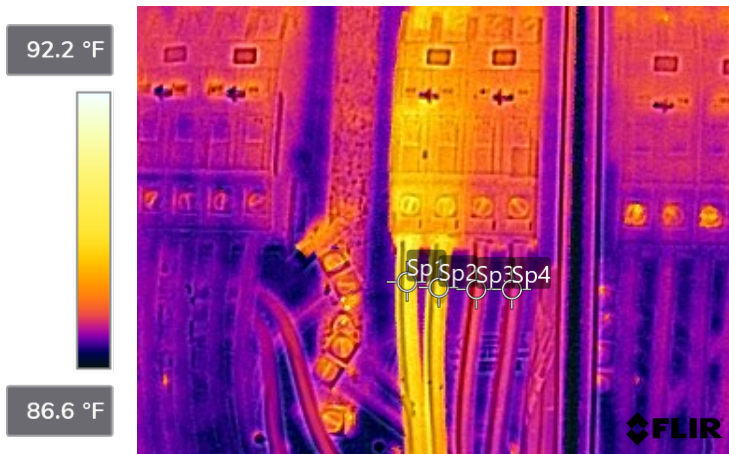
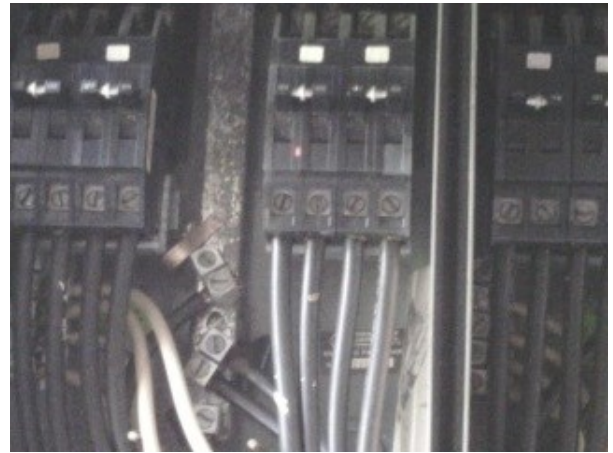
FLIR1920.jpg

Building 800 - Main Electrical Room - Main #2 - Units' Feeders and Main Circuit Breakers

Repairs Are Not Required

The temperature observed in the main circuit breaker is the result of the consumption measured at the time of the inspection.
 Phase A: 14 Amp
 Phase B: 15.7 Amp
 Deficiencies were not observed with this equipment at the time of the inspection.

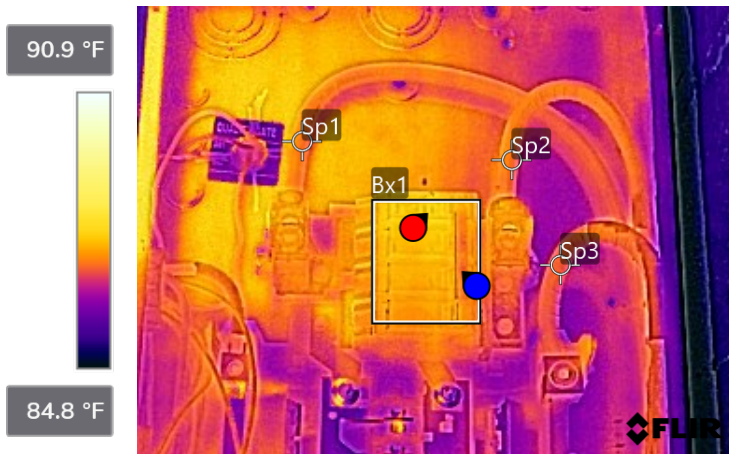
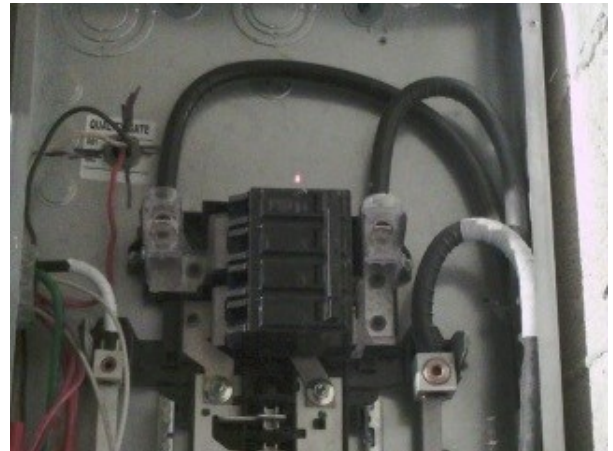
FLIR1896.jpg

Building 800 - Main Electrical Room - House Panel 1 - Feeders and Main Circuit Breaker

Repairs Are Not Required

Deficiencies were not observed at this equipment at the time of the inspection.

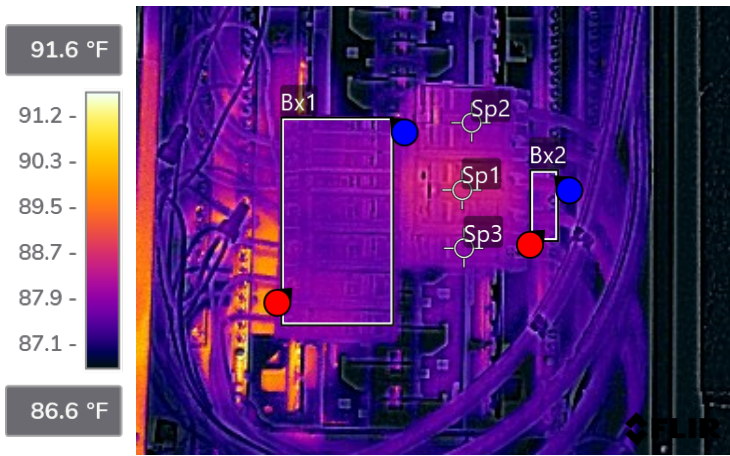
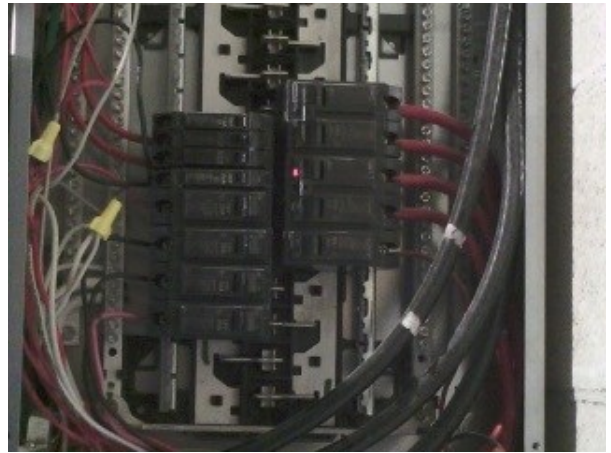
FLIR1898.jpg

Building 800 - Main Electrical Room - House Panel 1 - Circuit Breakers

Repairs Are Not Required

Deficiencies were not observed at this equipment at the time of the inspection.

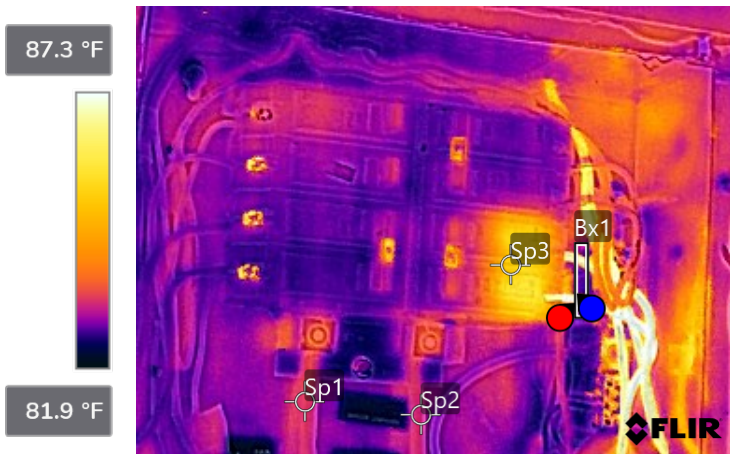
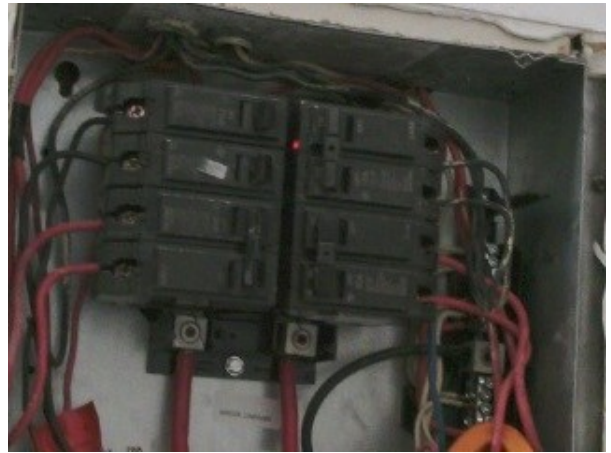
FLIR1878.jpg

Building 800 - Laundry Room - Electrical Panel

Repairs Are Not Required

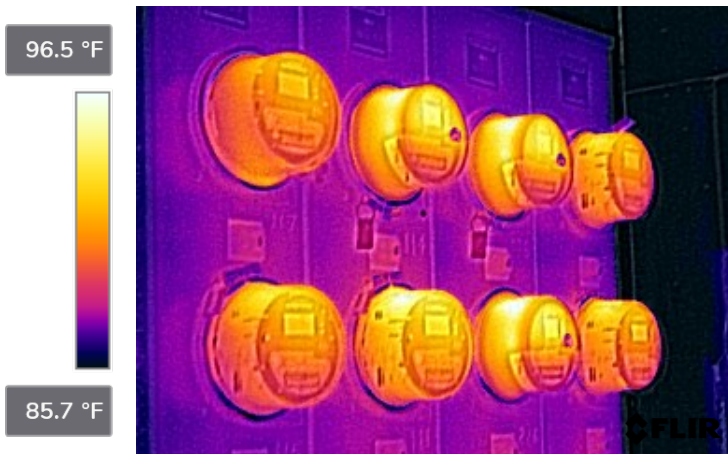
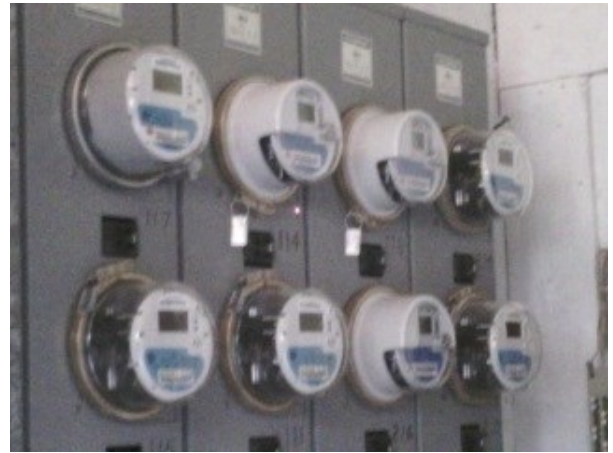
FLIR1940.jpg

Building 900 - Main Electrical Room - Main Service Disconnect #1 - Unit's Main Breaker and Meters

Repairs Are Not Required

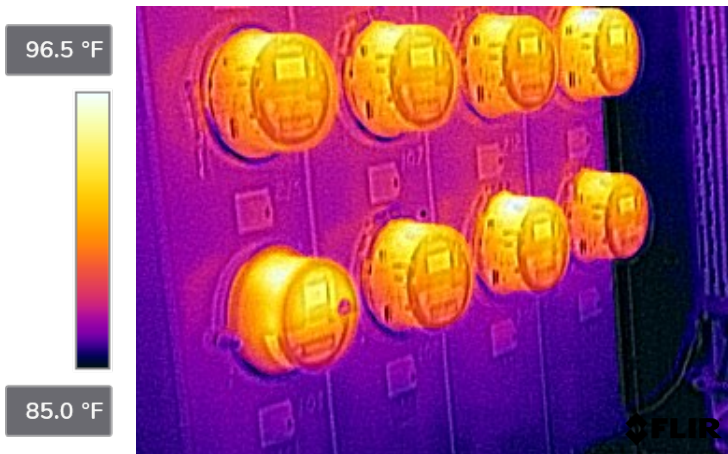
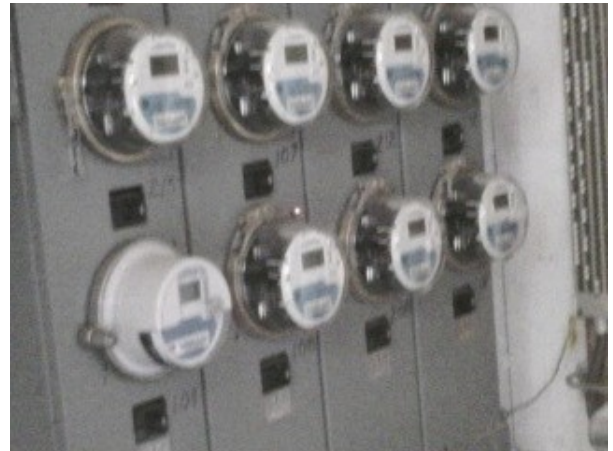
Building 900 - Main Electrical Room - Main Service Disconnect #1 - Unit's Main Breaker and Meters

Deficiencies were not observed at this equipment at the time of the inspection.

Repairs Are Not Required

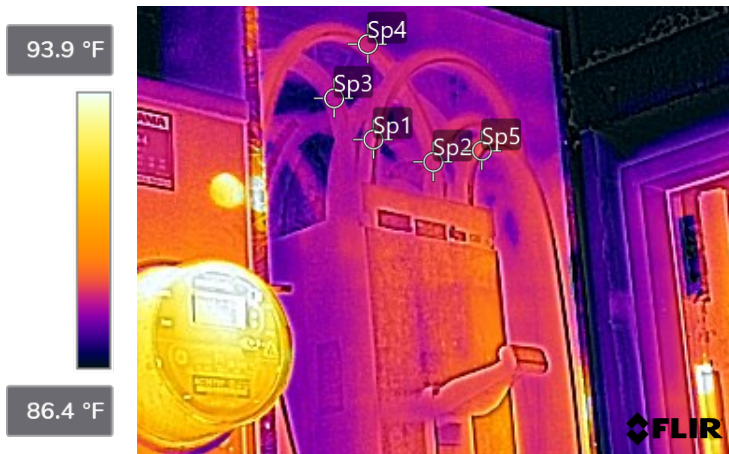
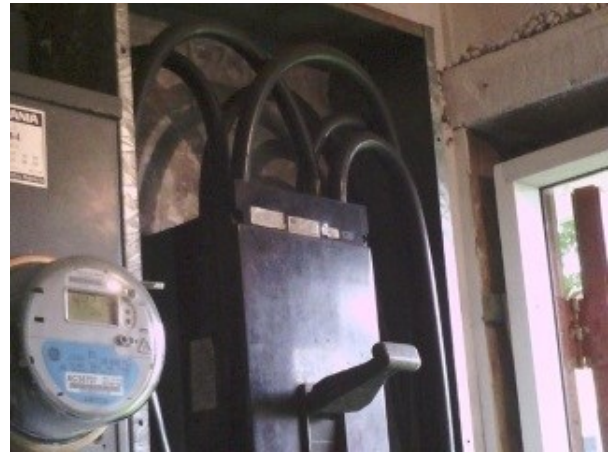
Building 900 - Main Electrical Room - Main Service Disconnect #2 - Feders and Circuit Breaker

Deficiencies were not observed at this equipment at the time of the inspection.

Repairs Are Not Required

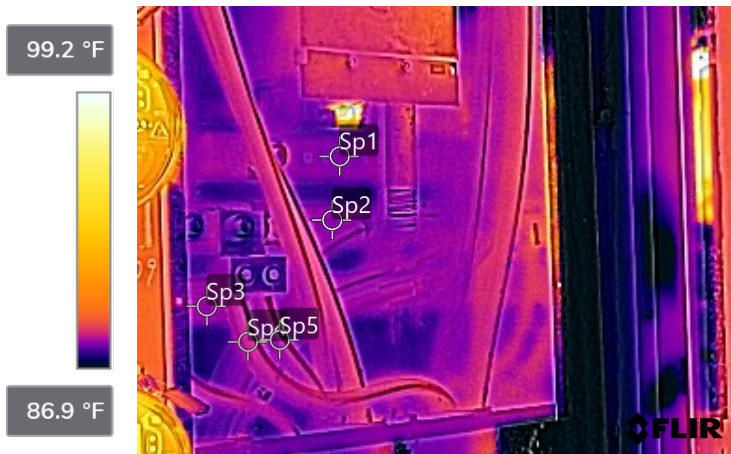
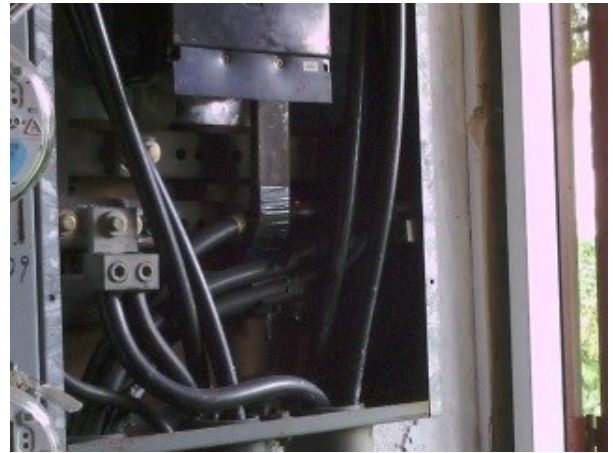
Building 900 - Main Electrical Room - Main Service Disconnect #2 - Circuit Breaker and Distribution Bars

Deficiencies were not observed at this equipment at the time of the inspection.

Repairs Are Not Required
