50-Year Recertification Thermography Report

Meadow Condominium Association, Inc
377 SW 56th Ave, Margate, FL 33068

MEADOWS CONDOMINIUM

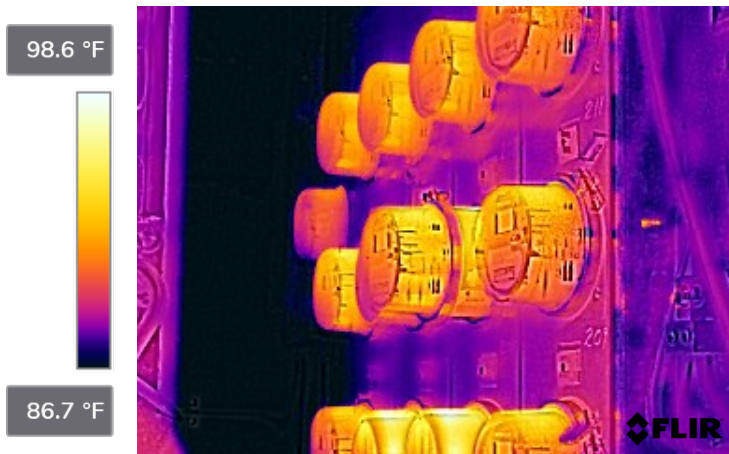
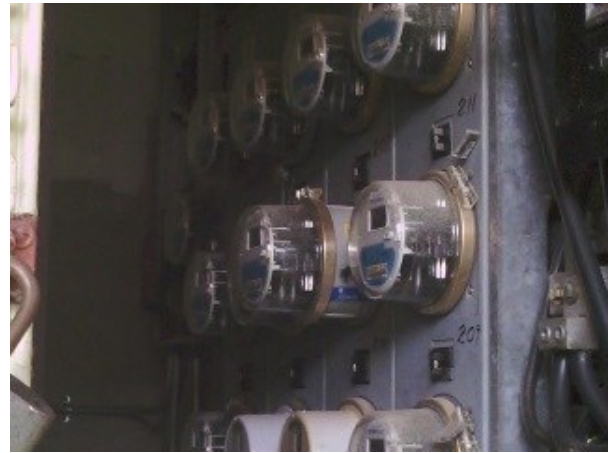
Building 900 - Main Electrical Room - Main Service Disconnect #2 - Unit's Main Breaker and Meters

Deficiencies were not observed at this equipment at the time of the inspection.

Repairs Are Not Required

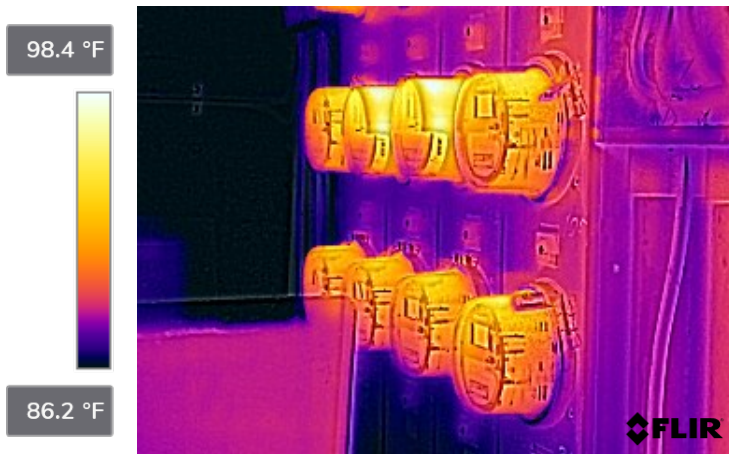
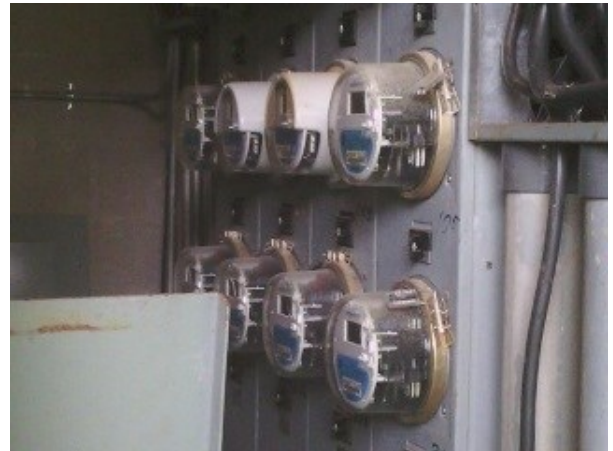
Building 900 - Main Electrical Room - Main Service Disconnect #2 - Unit's Main Breaker and Meters

Deficiencies were not observed at this equipment at the time of the inspection.

Repairs Are Not Required

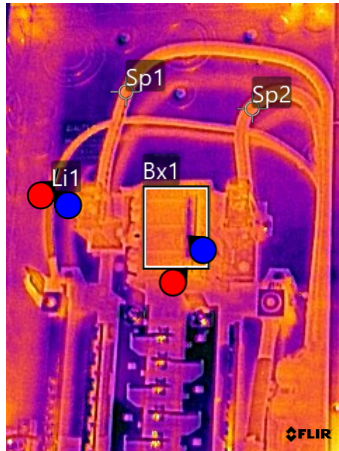
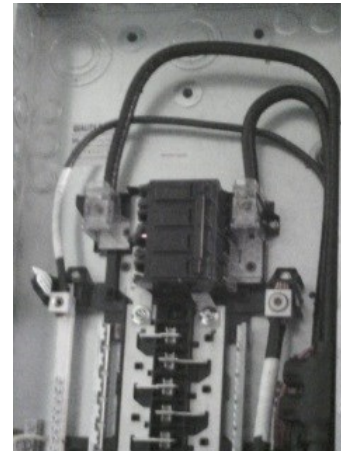
Deficiencies were not observed at this equipment at the time of the inspection.

Repairs Are Not Required

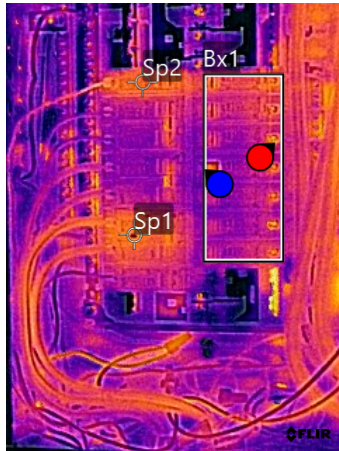
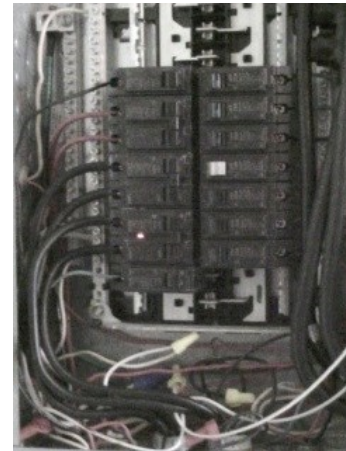
Deficiencies were not observed at this equipment at the time of the inspection.

Repairs Are Not Required

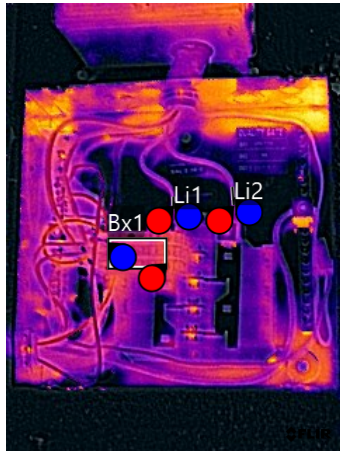
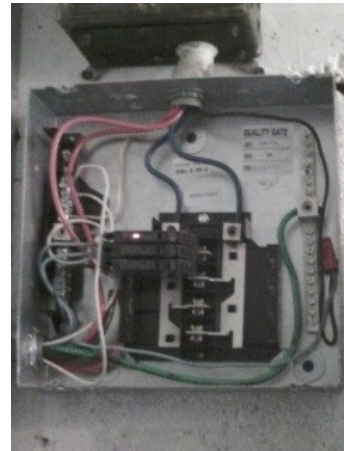
Deficiencies were not observed at this equipment at the time of the inspection.

Repairs Are Not Required

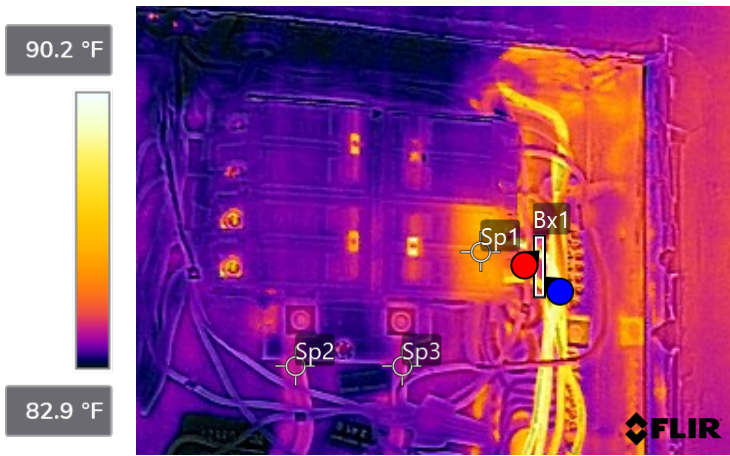
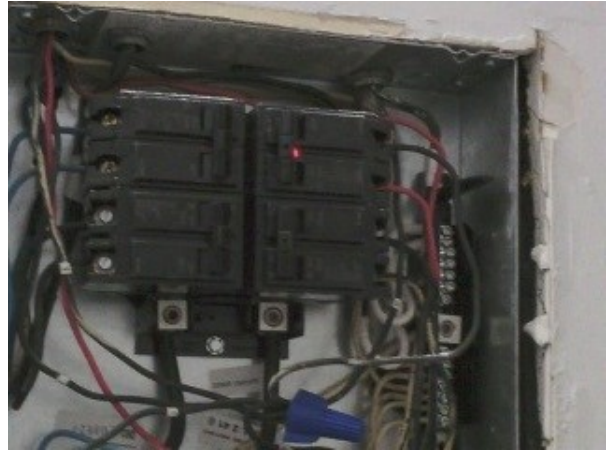
Building 900 - Laundry Room - Electrical Panel

The temperature observed in the 2P-30A circuit breaker is the result of the consumption measured at the time of the inspection.
 Phase A: 5.1 Amp
 Phase B: 3.8 Amp
 Deficiencies were not observed with this equipment at the time of the inspection.

Repairs Are Not Required
